Fracture analysis of the threaded joint of the level gauge in a reabsorption tower

Weige Meng^a, Shugen Xu^{a,*}, Ming Liu^b, Yanling Zhao^a, Yuan Zhang^a

^a College of Chemical Engineering, China University of Petroleum (Huadong), Qingdao 266580, China

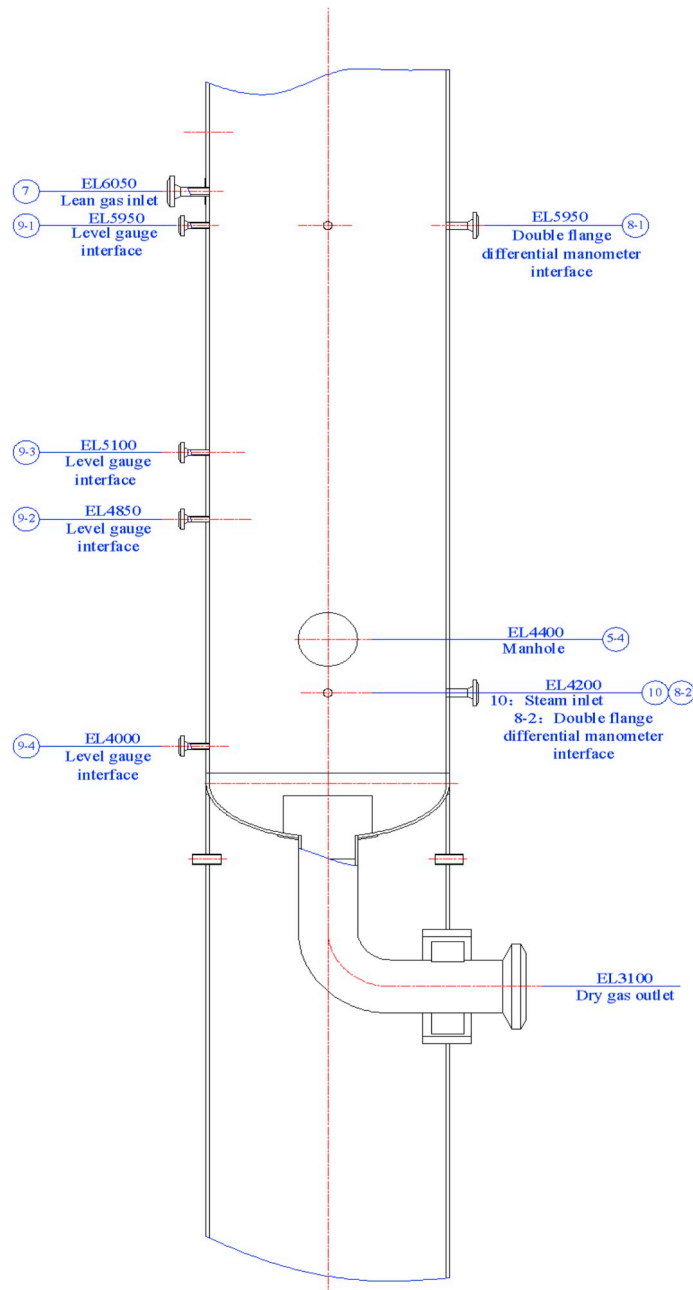
Fig. 1. The position diagram of level gauge of the reabsorption tower.

The leakage was found at the level gauge valve of the reabsorption tower, which was caused by the fracture of the stainless steel threaded joint of the level gauge. The level gauge had been put into use since February 2017 and had been used for 3 months. There were two level gauges used in series. Their relative position in the height direction of the reabsorption tower as shown in Fig. 1, the level gauge 9-1~2 at the top of the 9-3~4. The leakage threaded joint of level gauge was 9-4, and the elevation was EL4000.
