# Mitigation of floor heave in West Kentucky Coal Mine

A West Kentucky mine operation in No. 11 seam encountered floor heave, due to the localized increase in the thickness of the fireclay mine floor. Floor heave has overridden seals installed in two mined out panels. The third seal's location was planned for isolating that area from the Mains. A plan of support has been developed to prevent repetition of the floor heave and related problems outby the seals. The applied ground control measures were successful. An attempt of a 3D numerical modeling was made; thus, it would match the observed behavior of the mine floor and could be used as a design tool in similar conditions. The paper describes sequence of events, an applied mitigation ground control system, and the first stage of numerical modeling.

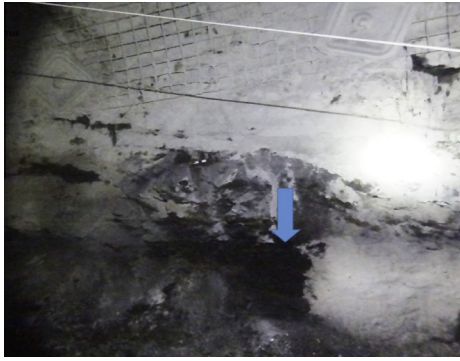
As noted in Fig. 1, an arrow shows the change of strata, and fireclay (FC) thickness around 1.5 m out of it a top of 10.16 cm is soft and rooted, below that FC is still weak but less rooted, and its strength increases with depth as it becomes more limey and sandy.

Fig. 1. View of floor composition at undercast.

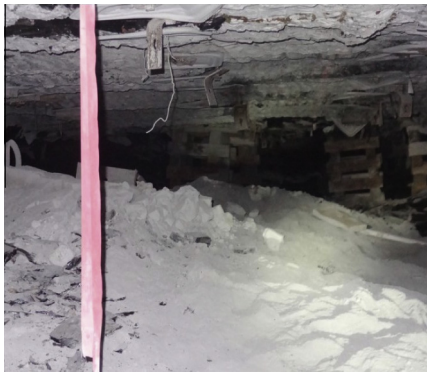
Fig. 2. Floor heave in the area without support.

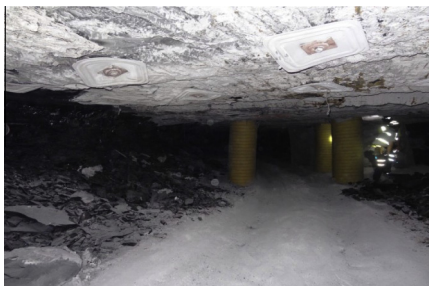
Fig. 3. Rib failure and spalling.

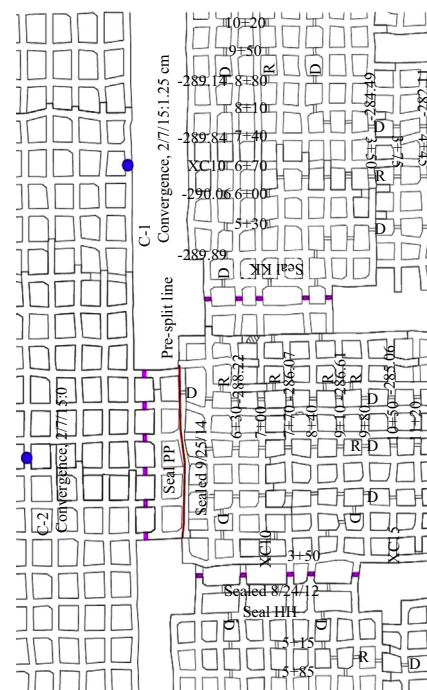
Seals KK were overridden from severe heaving, pillar/rib failures, and damage to standing support; blue dots are convergence stations; and orange presplit line created in strong roof strata (Fig. 4).

Fig. 4. Map of the area to be sealed (PP).
