Acute transient non-physiological over-sensing in the ventricle with a DF4 lead

Kevin Kit Ng^a, Paul A. Gould^{b,*}^a Princess Alexandra Hospital, Department of Cardiology, Queensland, Australia^b Princess Alexandra Hospital, Department of Cardiology, University of Queensland, Department of Medicine, Brisbane, Australia

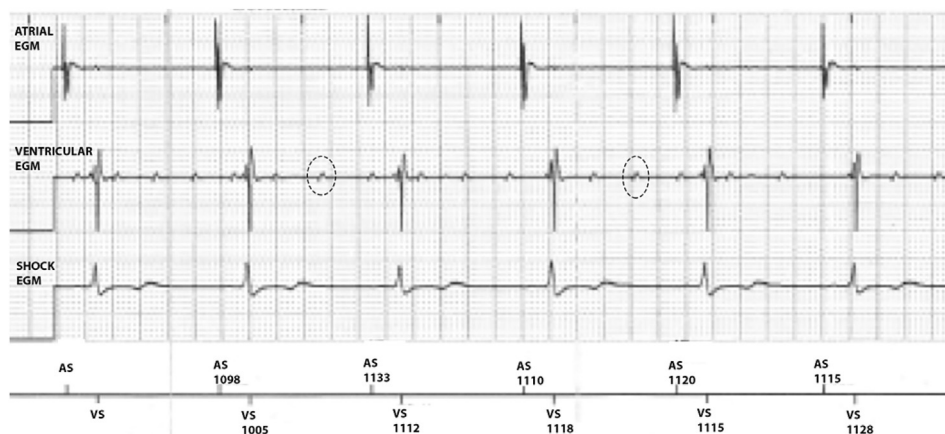
Fig. 1 – EGM post DFT revealing low amplitude signals seen on the ventricular channel (circled) but not sensed by the device (as evidenced by absent sensed ventricular beats – VS, on the marker channel corresponding to the artefacts). EGM channels for both upper and lower panels: First line = Atrial EGM, Second line = Ventricular EGM, Third line = Shock EGM (distal coil to can), Fourth line: Atrial and ventricular pace/sense marker channel. AS = Atrial sensed beat, VS = Ventricular sensed beat.

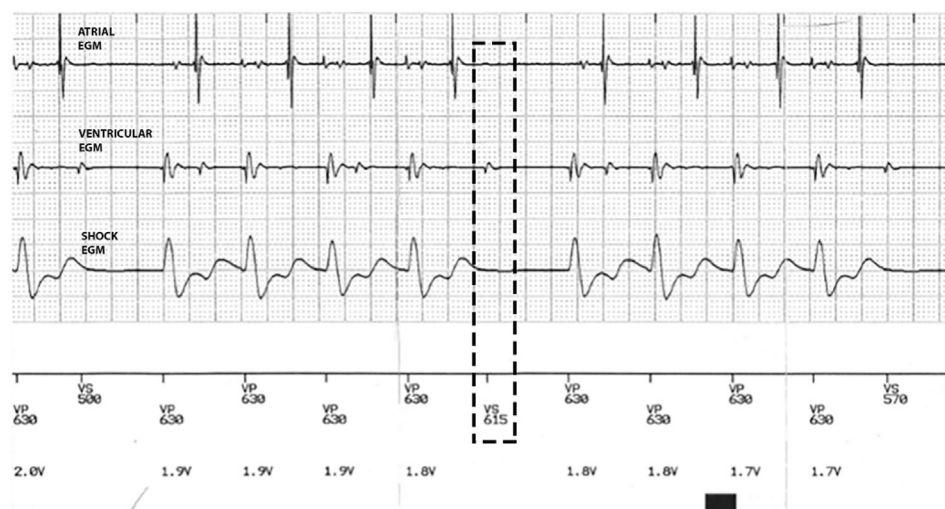
sensing of 7.9 mV, impedance of 960 Ω , threshold of 0.6 V @ 0.5 ms, and a high voltage impedance of 39 Ω) and defibrillation threshold testing (DFT) was acceptable. Baseline sensing was set at 0.5 mV. Subsequent to defibrillation testing, unusual low amplitude and medium frequency signals were observed on the ventricular EGM (Fig. 1) and detected on the marker channel during pacing threshold testing (Fig. 2) which were clearly not related to T-wave over-sensing.

Fig. 2 – EGM post DFT threshold testing showing ventricular over-sensing of the artefact during pacing threshold testing (denoted by rectangular box showing that the artefacts are now being sensed by the device as VS, on the marker channel). EGM channels for both upper and lower panels: First line = Atrial EGM, Second line = Ventricular EGM, Third line = Shock EGM (distal coil to can), Fourth line = Atrial and ventricular pace/sense marker channel. Fifth line = Pacing output. AS = Atrial Sensed Beat, VS = Ventricular Sensed Beat, VP = Ventricular Paced Beat.

Fluoroscopic review of set-screw positioning was unremarkable and manipulation of the device did not influence the signals. No further intervention was performed at that stage and pacing threshold testing the next day demonstrated no over sensing recurrence and he proceeded to have an event free six-week follow-up.
