Clay brick masonry facades with cracks caused by corroding bed joint reinforcement – Findings from field survey and laboratory study

Miklós Molnár, Oskar Larsson Ivanov*

Structural Engineering, Lund University, P-O Box 118, SE-22100 Lund, Sweden

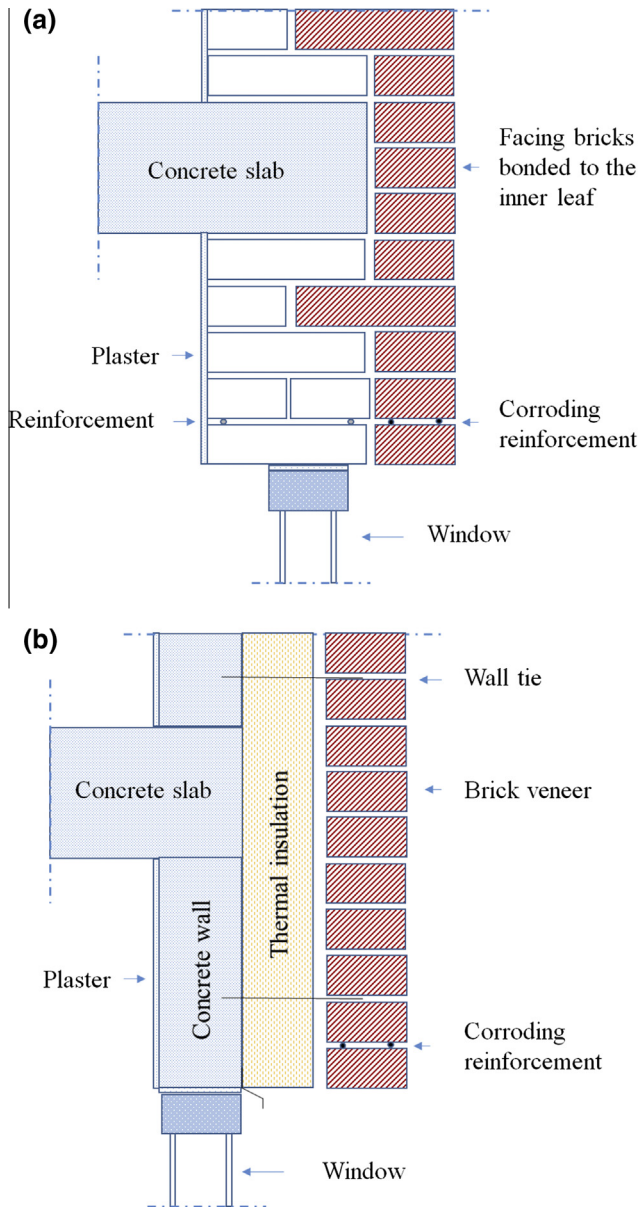
Fig. 1. Wall sections with corroding bed joint reinforcement: a) faced single leaf brick wall; b) brick veneer.

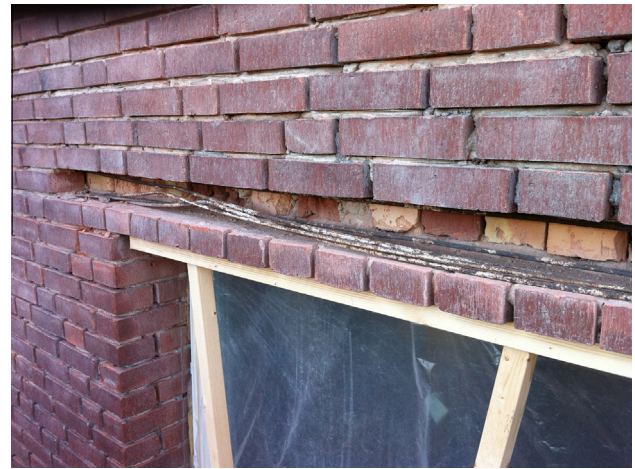
Fig. 2. Retrofitting of window beam with corroding bed joint reinforcement.

Cracks formed in bed joints containing corroding reinforcement can impair aesthetics and increase moisture up-take with associated proneness to frost damage, microbiologic growth and increased heat loss, see Fig. 2. In advanced stages of corrosion, the load bearing capacity of masonry beams may also be affected [8]. As the post-war building stock contains many culturally valuable masonry buildings, there is an increased interest in development of lenient retrofitting techniques [13].

In order to stop further corrosion related damage, the corroding bed joint reinforcement is usually removed and, when necessary, replaced by reinforcement of stainless steel. As a basis for decision making concerning retrofitting measures, cracked bed joints are identified by ocular inspection of the façade. In most cases, no further assessments or analyses are carried out, e.g. regarding the condition of the reinforcement or the expected development of corrosion related cracking [1,16].

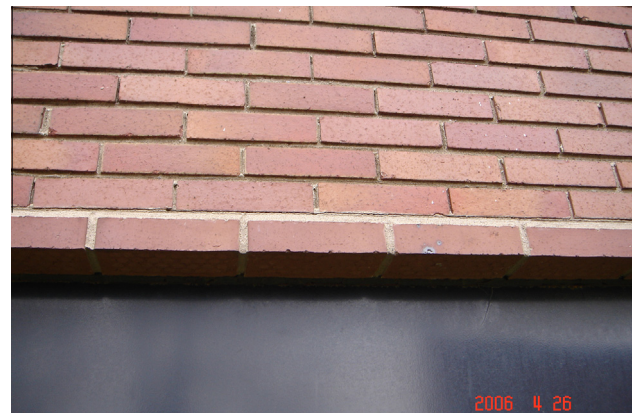
The extent of retrofitting varies between partial to total removal of the reinforcement from cracked bed joints or from the entire façade. In some cases, only repointing of cracked bed joints is carried out, without removal of any reinforcement. If the corroding reinforcement is not removed, the new bed joints will crack in a few years thus making such a measure inefficient, see Fig. 3. The final choice of retrofitting strategy is influenced by factors such as: a) the extent of cracking in the façade – if the proportion of cracked bed joints is considered low, partial retrofitting is preferred while total retrofitting is often preferred when cracking is extensive; b) the competence of the client, of the building contractor or, if involved, of the technical consultant; c) the economic situation of the client; d) concerns regarding increased moisture content in the external walls with associated problems. In either case, façade retrofitting projects are costly, since scaffolding has

Fig. 3. Repointed bed joint that cracked due to further corrosion of the reinforcement.
