Professional Practice Paper

Development and management of geomembrane liner hippos

Fred Gassner

Golder Associates Pty Ltd, P O Box 6079, Hawthorn West, Victoria, 3121, Australia

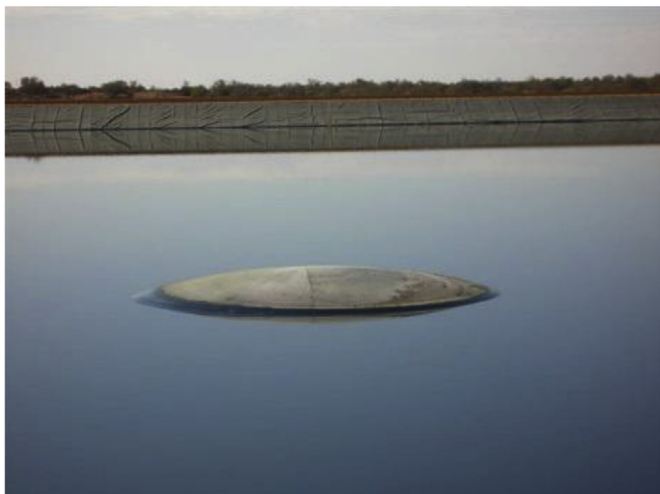
Fig. 1. Typical liner hippo.

During the operation of the pond it was noted that a liner hippo started to form. The size of the liner hippo progressively increased to a size that a surface expression of the geomembrane liner of approximately 5 m in diameter appeared above the liquid level of the pond. Fig. 1 in the introduction shows the bubble. The owner believed that the Liner Hippo was related to trapped air or gas and requested some assistance from a Contractor. The Contractor attempted to deflate the bubble by inserting a flexible pipe between the geomembrane and clay liner, but was unsuccessful in deflating the Liner Hippo. The author of this paper was then engaged to investigate the issue. Following the emptying of the pond it was evident that the size of the Liner Hippo had been much larger than expected by the owner. Fig. 3 shows the size of the remnants of the Liner Hippo, which can be seen by the circle in the dried sludge that had formed on top of the geomembrane liner. The thickness of the sludge within the circle on the geomembrane was generally only a few millimeters. The Liner Hippo was approximately 35 m diameter on the pond floor and a few meters diameter at the surface of the stored liquor.
