Electric Power Systems Research

Analysis of two nonfatal lightning accidents in Colombia

Jorge A. Cristancho C. *, John J. Pantoja, Carlos Rivera, Francisco Roman

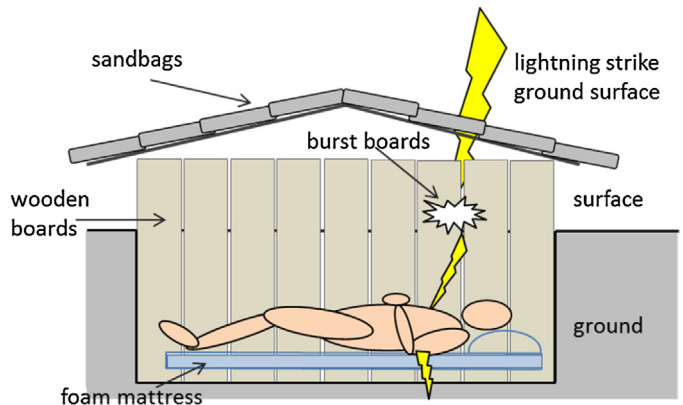
Fig. 2. Schematic representation of Case A, in which a soldier was resting inside of a semi-underground military shelter, which was struck by lightning.

Lightning struck directly on the ground surface circa 1 m from the shelter roof and the lightning current, instead of being dissipated on the surrounding ground, part of it flowed across the trench walls arrangement, breaking them and reaching the soldier's right side. The indirect lightning current left three diverted recognizable burn paths on the sergeant's skin, as shown in the photographs in Fig. 4. From these images, the indirect lightning current paths in the victim's body could be reconstructed. The lightning probably hits initially close to his right shoulder. Thereafter the current crossed superficially his right shoulder and was routed to the portable communication radio placed over the sergeant's torso and through the necklace he wore, ending at the elbow's area of his left arm. Fig. 4(a)–(f) shows the burns left by the lightning current on the soldier's body, on the necklace and on the sergeant's portable communication unit.
