Case Studies in Engineering Failure Analysis

Forensic investigation of a failed connecting rod from a motorcycle engine

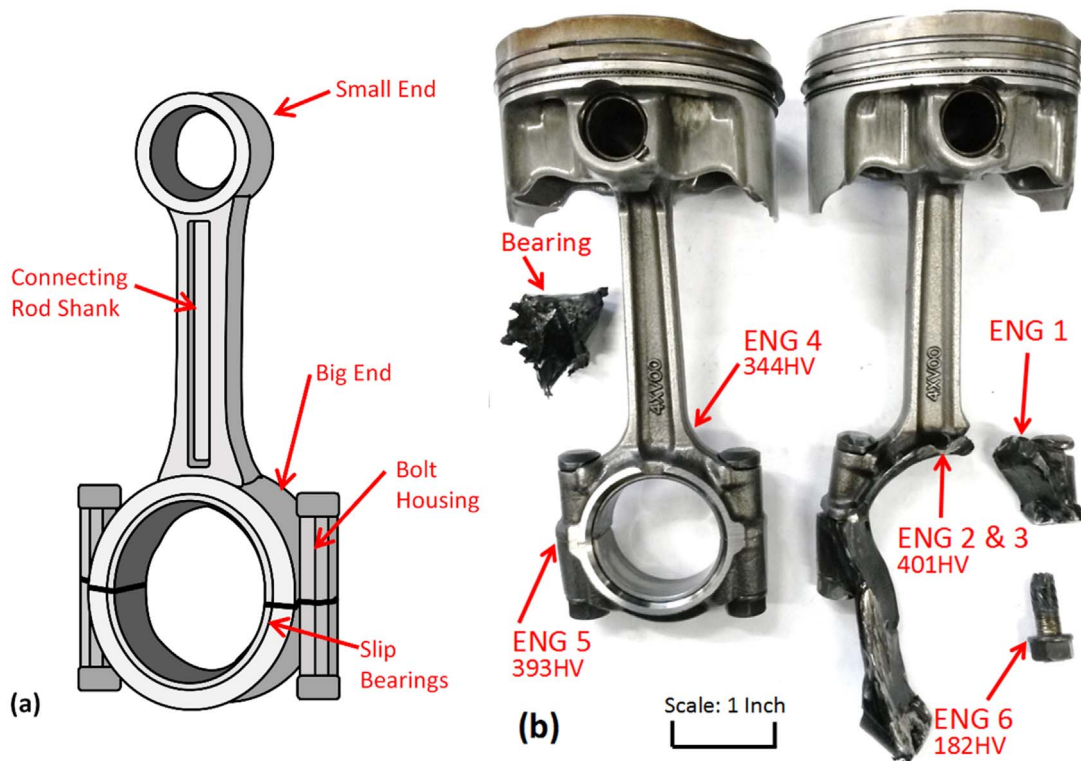
Fig. 1. (a) Diagram of an assembled connecting rod, rod cap, bolts and slip bearing with key features and components annotated in red; (b) The intact and failed connecting rod and piston assemblies, left and right consecutively, are shown with the failure.
