Case Studies in Engineering Failure Analysis

Failure analysis of dissimilar weld in heat exchanger

Carlos R. Corleto*, Gaurav R. Argade

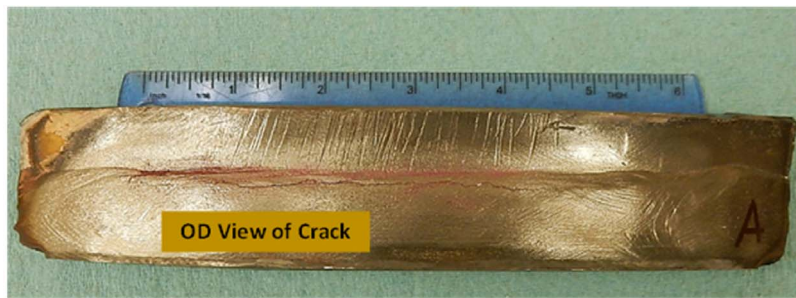
The as received sample extracted from the heat exchanger for this analysis, exposed crack fracture surfaces after sectioning, and illustration of crack location are shown in Fig. 1. The through thickness crack extended approximately 5 in. circumferentially near the top side of the exchanger. The crack initiated and propagated mostly along the weld metal side of the fusion line with the carbon steel except near the OD, where it propagated into the weld metal away from the fusion line. The discoloration seen in Fig. 1(b) appears to be consequential oxidation after the failure, especially on the carbon steel side of the fracture surface. Note that at this location, the weld was approximately 0.1" thinner than the rest of the weld. No evidence of initial weld defects such as incomplete fusion and lack of penetration were observed.

Fig. 1. Circumferential crack in the dissimilar metal weld: (a) as received sample extracted for failure analysis (~8-in. long, 1.75-in. wide, and 0.5-in. thick); (b) exposed crack fracture surfaces after sectioning; (c) illustration of crack location.
