6th Asia Pacific Workshop on Structural Health Monitoring, 6th APWSHM

A suggestion of health monitoring for road bridge shoes

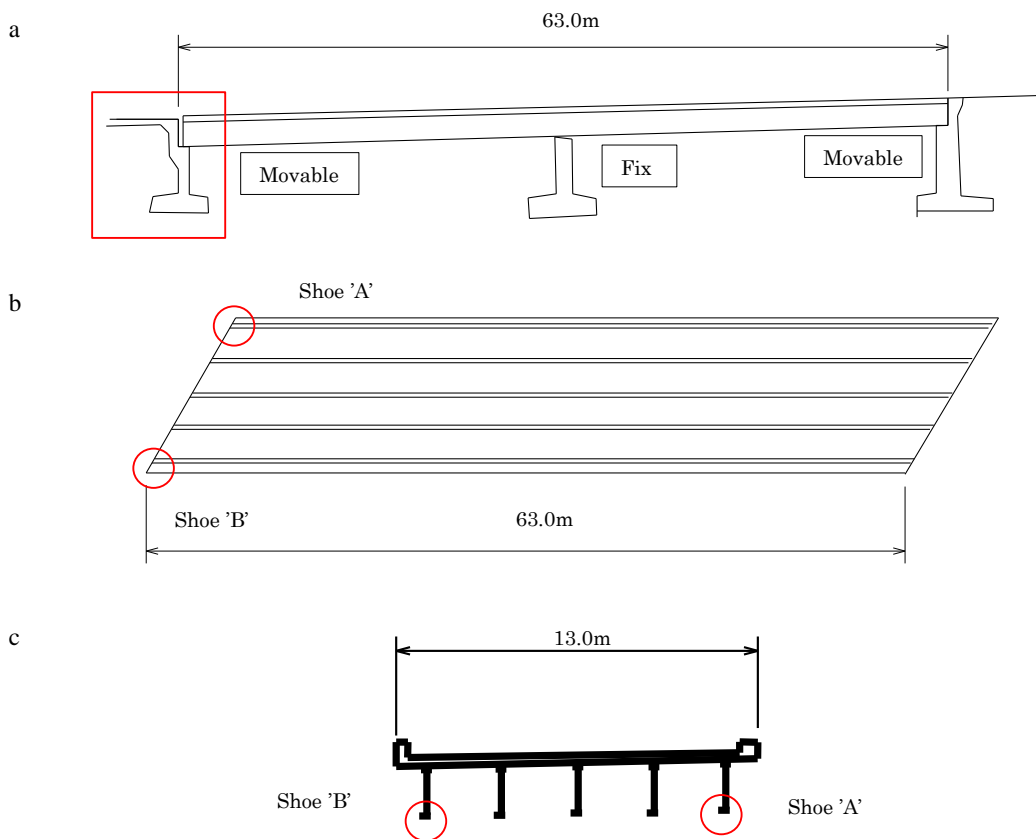
The structural drawing of the monitored bridge is shown in Fig.1. The bridge is 63.0m in length and has two continuous spans supported by three piers. The bridge has a skew angle of 60 degree. The shoe on the central pier is fixed and right and left side shoes are movable. The bridge consists of five main beams, and five shoes are installed on each pier. Two shoes 'A' and 'B' on the left side pier were monitored as shown in Fig.1.

Fig.1. Structural drawing of the bridge (a) side view; (b) plan view; (c) cross view.
