A microstructure-based mechanism of cracking in high temperature hydrogen attack

M.L. Martin ^{a, b, *}, M. Dadfarnia ^{a, b}, S. Orwig ^c, D. Moore ^c, P. Sofronis ^{a, b}

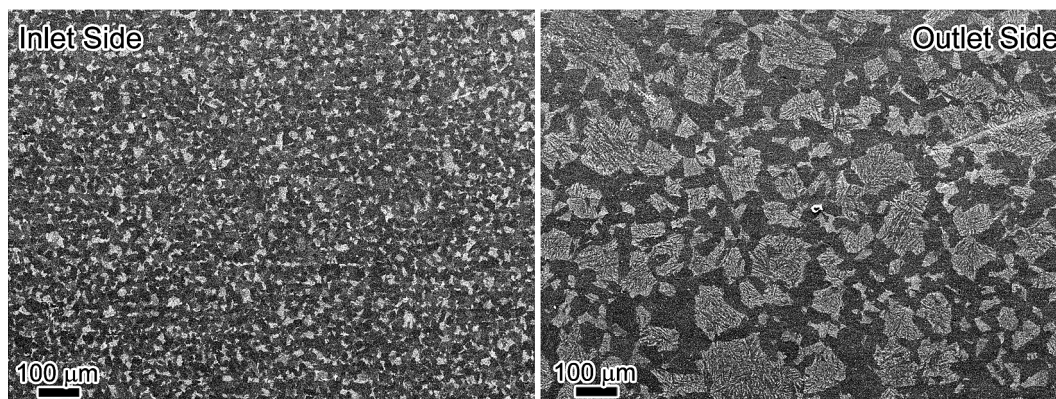
elevated temperatures is unknown. The pearlite structure is a little unusual, tending to occur in packets of cementite plates separated by regions of clean ferrite, all within the same grain. This is likely due to the extended lifetime at elevated temperature, though it is unclear if dissolution and reaction with the hydrogen was also an important factor in the development of this microstructure.

Fig. 1. C-½Mo steel microstructure at different locations on the reboiler after 53 years in service at 400 °C (inlet side) or 385 °C (outlet side) with partial pressure of H₂ of 1.5 MPa. SEM micrographs.
