2nd International Conference on Structural Integrity, ICSI 2017, 4-7 September 2017, Funchal, Madeira, Portugal

## Failure investigation of the crankshaft of diesel engine

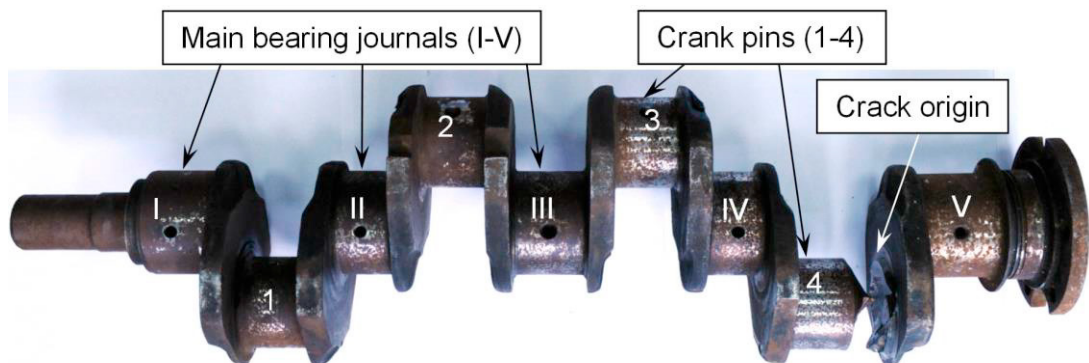
The crankshaft of S-4003 engine was ruptured in region of the crank pin no. 4 (Figs 1 and 2a) after about 5500 hours of engine operation. S-4003 is naturally aspirated diesel engine used for power of the tractor. The engine displacement is 3120 cm<sup>3</sup>. The maximum power equals 33.12 kW at rotational speed of 2000 RPM.

Fig. 1. Crankshaft of S-4003 engine after failure.
