XXIV Italian Group of Fracture Conference, 1-3 March 2017, Urbino, Italy

Failure analysis of a diesel engine

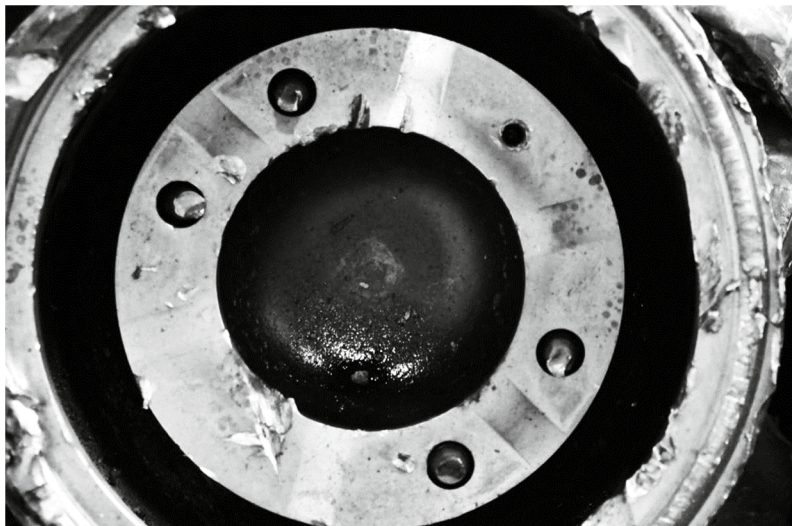
The failure was located in one of the engine cylinders and caused the breakage of a large number of parts of that area, such as pistons, connecting rods, bolts and even the connecting rod broke the wall of the monoblock. Upon careful examination of the fractured fragments, it was observed that in the component called crown of the cylinder, it had the four fixing bolts fractured. By looking closely at the fracture surfaces of the bolts, three were found to be fractured by over-loading, ie, they broke suddenly and in one event, whereas a bolt presented an invoice identified as fatigue.

Fig. 1. View of the crown of the cylinder where the four fractured crown bolts are observed, the bolt indicated by the arrow shows a fatigue fracture, while the remaining three have an overload fracture.
