The menace of the Geo-Environmental hazard caused by gully erosion in Abia State, Nigeria

K.C. Onyelowe

Department of Civil Engineering, Michael Okpara University of Agriculture, Umudike, P.M.B. 7267, Umuahia 440109, Abia State, Nigeria

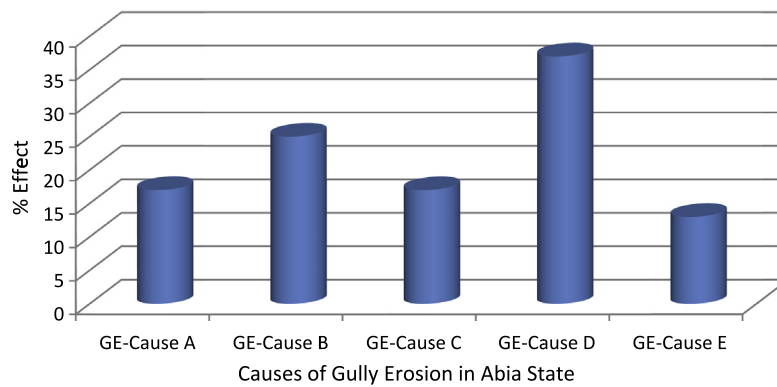
Fig. 1. Percentage effect of the causes of Gully erosion in Bende LGA.
