## Safety issues related to the maintenance operations in a vegetable oil refinery: A case study

Gabriele Landucci <sup>a,\*</sup>, Gianfranco Lovicu <sup>a</sup>, Federica Barontini <sup>a</sup>, Luca Guidi <sup>b</sup>, Cristiano Nicoletta <sup>a</sup>

<sup>b</sup> SALOV – Società Alimentare Lucchese Oli E Vini S.p.A., Via Montramito n. 1582, San Rocchino, LU 55054, Italy

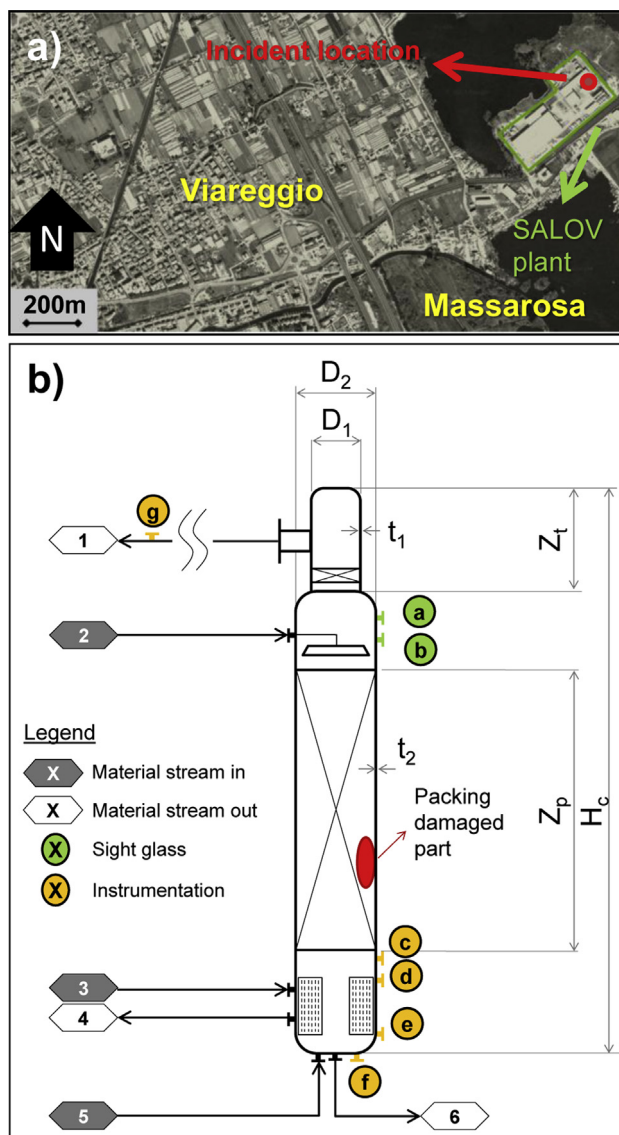
Fig. 1. a) Overview of the incident area, the plant and the damaged column location; b) process scheme and sketch of the damaged column. For items definitions and dimensions refer to Table 1.

The incident occurred in the deodorization column of SALOV S.p.A. refinery during the night between September 26th and 27th 2012. The refinery is located in Massarosa (Italy), between vulnerable residential areas of Viareggio and Massarosa as shown in Fig. 1a.

A schematic representation of the process is shown in Fig. 1b, in which the available instrumentation is also reported. A summary of the features of the column and column accessories is reported in Table 1.

On September 26th, the unit was removed from service following a specific SALOV procedure, which consisted in closing the heating steam feed and waiting till the temperature, measured by the indicator shown in Fig. 1b, reached 80 °C. After the shut down, a maintenance operation was scheduled on the liquid level transducers (see Fig. 1b). During the afternoon of the same day, the maintenance operators removed the mentioned instrumentation opening the column to the atmosphere without a preliminary nitrogen blanketing, not requested by the shut down procedure due to the absence of any hazardous substance in normal conditions. At 8:00 pm, both the maintenance and process operators left the plant.

When the morning shift of September 27th started (7:00 am), no significant change in the column operating parameters was observed. In particular, data recorded by the available instruments (see Fig. 1b) showed 1.01 bar pressure and 32 °C temperature.
