# Mechanism of tunneling-induced cave-in of a busy road in Fukuoka city, Japan

A road cave-in accident caused by tunneling is described, and the possible mechanism of failure is analyzed. The cave-in measured about  $30\text{ m} \times 27\text{ m}$  in plane, and about 15 m in depth. At about 19 m below the ground surface at the site, a tunnel construction was underway. Immediately above the tunnel, there was a weathered shale layer approximately 2.66 m thick; above this layer, there were sand and gravel layers. The groundwater level was estimated to be about 5 m below the ground surface. By arch analysis, it is shown that the most likely cause of the accident was the low strength of the weathered shale layer and the high water pressure above the tunnel, which resulted in tensile failure of the weathered shale layer. The All Ground Fasten (AGF) pre-support measure was adopted, but it might make very limited contribution to the increase in the tensile strength of the shale layer in the cross-sectional direction of the tunnel. © 2018 Tongji University and Tongji University Press. Production and hosting by Elsevier B.V. on behalf of Owner. This is an open access article under the CC

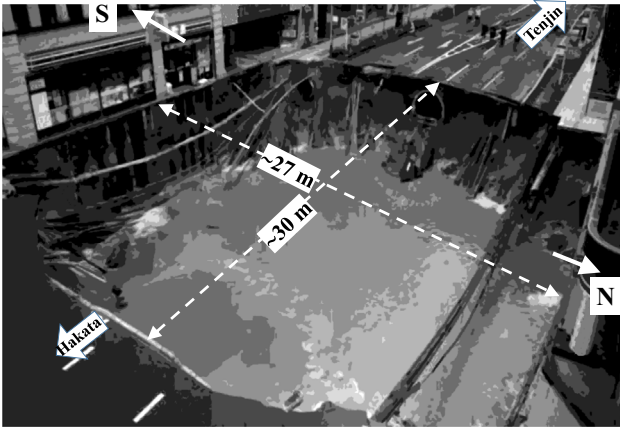
(2) At around 7:20 AM, a large cave-in occurred with the size of approximately  $30\text{ m} \times 27\text{ m}$  and approximately 15 m in depth, as shown in [Fig. 1](#) (produced based on the information from [FTB \(2017\)](#)).

It appears that the water level in the cave was at a depth of about 5 m (the depth of the water level was more than the height of one story of the adjacent building) from the ground surface. As can be seen from [Fig. 1](#), the cave-in broke the underground gas, water, and sewer lines, and snapped the electricity and telecommunication cables.

Fig. 1. Road cave-in in Hakata-ekimae-tori.

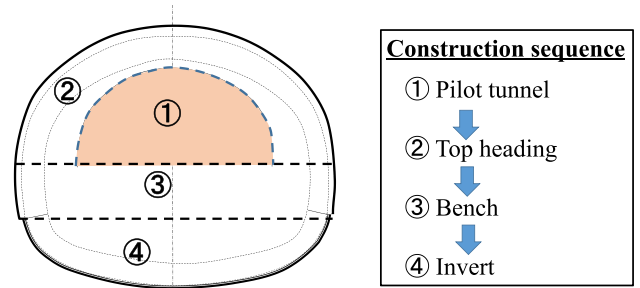
Fig. 3. Illustration of the tunnel construction sequence.

followed by top heading, bench, and invert excavations, as illustrated in Fig. 3. At the time when the accident occurred, the top heading excavation had been completed. Inside the tunnel, the following events happened at dawn on November 8, 2016.

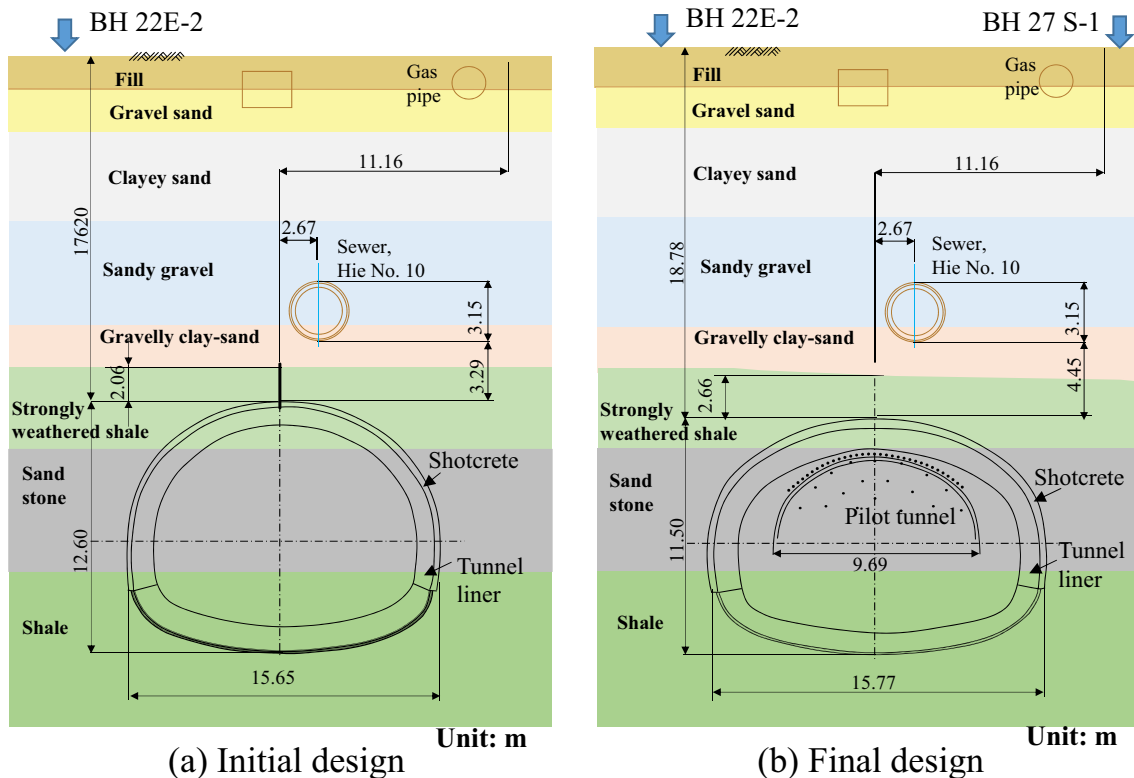
width of 15.77 m and height of 11.50 m, as shown in Fig. 2 (b). At this section, the construction method adopted was the New Austrian Tunneling Method (NATM). The All Ground Fasten (AGF) method was used as a pre-support measure. The AGF steel tubes had a diameter  $\phi = 114.3$  mm; the wall thickness of the tube was 6 mm, and the length of each tube was 9.5 m. There were 33 tubes installed in approximately  $120^\circ$  range around the crown on the cross-section, but the lap length in the longitudinal direction is not known. The inclination angle between the tubes and the horizontal was approximately  $10^\circ$ . The designed excavation procedure was pilot excavation

Fig. 2. Design cross-sections of the tunnel. Initial design; (b) Final design.
