Case study

Failure analysis of a diesel generator connecting rod

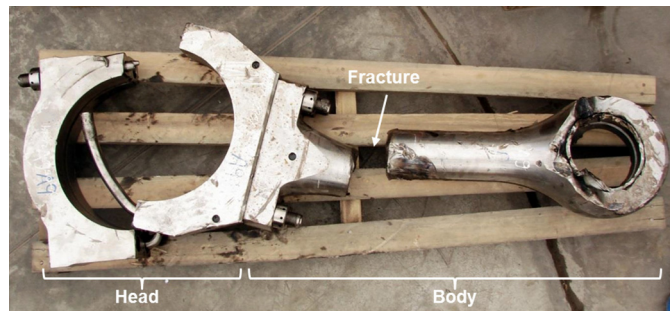
This paper presents the results of a failure analysis investigation conducted in a connecting rod from a diesel engine (18 V, four-stroke) used in the generation of electrical energy. The continuous output of the engine was 10.5 MW, at 600 rpm; before the failure of the con-rod it accumulated 35836 service hours, working with a load factor of 80%. The connecting rod (total length: 1463 mm, weight: 134 kg) had a drilled channel along its body, through which pressured lubrication oil was transported to the piston pin. Fig. 1 shows the failed con-rod, which fractured in the body section, close to the head.

Fig. 1. Failed connecting rod.
