Failure analysis of 316L stainless steel crucible by molten fluoride salt interaction with clay bonded silicon carbide

Detailed investigation of a recently failed static corrosion test involving molten eutectic LiF–NaF–KF salt at 850 °C contained in 316L stainless steel crucibles shows that a single sealed crucible leaked molten salt into the electric furnace due to mechanical failure, causing a chemical reaction between the molten salt and the clay bonded silicon carbide insulation used in the furnace. As a result, corrosive vapors of Na_2SiF_6 , K_2SiF_6 , SiF_3 , and F_2 , were formed. These vapors reacted with the stainless steel crucibles and lead to the formation of a porous corrosion crust and the eventual catastrophic structural failure of all nine sealed 316L stainless steel crucibles.

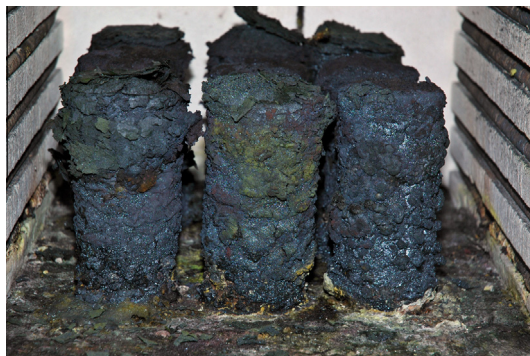
Fig. 1 shows visual characteristics of the crucibles and the high temperature electric box furnace after the termination of the test. A close up comparison of a corroded crucible and a crucible prior to testing is shown in Fig. 2. The scale formation is porous and brittle with shiny metallic sections and areas of green, white, purple, and red residue. The crucible interiors show relatively thin predominately red scale formations. Two steel sheathed type K thermocouples were used to monitor the internal temperature. Both were nonoperational due to heavy corrosion at the conclusions of the 1000 h test. The alumina sheathed type S control thermocouple remained operational the entire time and appeared unaffected. Throughout the duration of the test, the furnace was held at slight positive pressure with nitrogen cover gas making oxygen ingress unlikely.

Fig. 1. Photograph of crucibles at the conclusion of the 1000 h static test.
