Disaster of the bucket wheel excavator caused by extreme environmental impact: Consequences, rescue and reconstruction

ABSTRACT

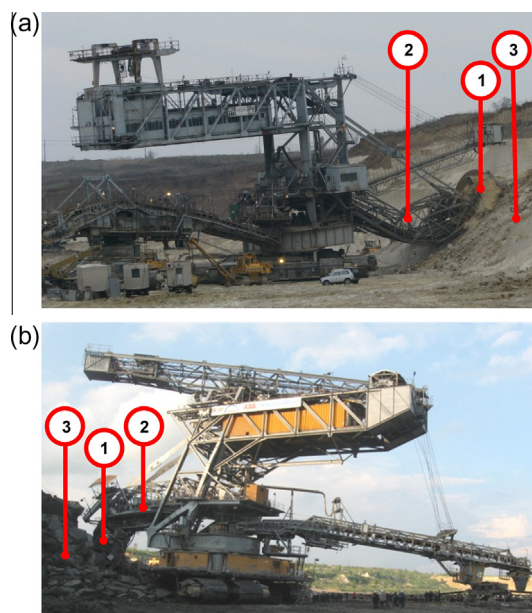
to the occurrence of the so-called 'environment-in' defects [22]. Typical examples of extreme environmental impacts on the BWEs are slope failures, Fig. 1, which caused severe accidents of BWEs used for overburden digging and deposit in the open pit mine "Kolubara" – Serbia.

This paper is dedicated to the engineering challenges that accompanied the process of returning the BWE SRs 1200 from the state after the accident, Fig. 1a, to the state of full exploitation readiness. Its importance stems from the fact that presented technologies of rescue, repair and reconstruction in field conditions can be applied for solving the same, Fig. 1b, or similar problems which could arise during the exploitation of surface mining systems.

Fig. 1. Typical accidents caused by slope failure: (a) BWE SRs 1200; (b) BWE SRs 1301 (1 – bucket wheel, 2 – bucket wheel boom, 3 – failed slope).
