The Knee

Case report

Polyethylene liner dislocation of fixed-bearing medial oxinium unicompartmental arthroplasty with severe metallosis

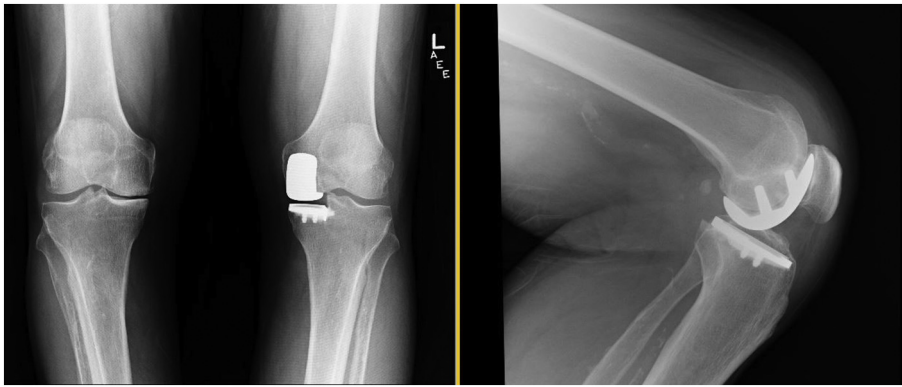
The patient underwent successful left knee unicompartmental arthroplasty in December of 2011 without complication (Femur size 5, tibia size 4, insert size 8 mm). The patient was progressing appropriately at the 4-week post-operative follow-up, and subsequently underwent right knee unicompartmental arthroplasty in January of 2012, 6 weeks after the surgery on the right side, without intra-operative complication (femur size 6, tibia size 4, insert size 8). Likewise, at 6-week follow-up after the right knee surgery he was progressing as expected. Post-operative radiographs are shown in [Figures 1 and 2](#).

Figure 1. Post-operative radiographs following primary left unicompartmental arthroplasty.

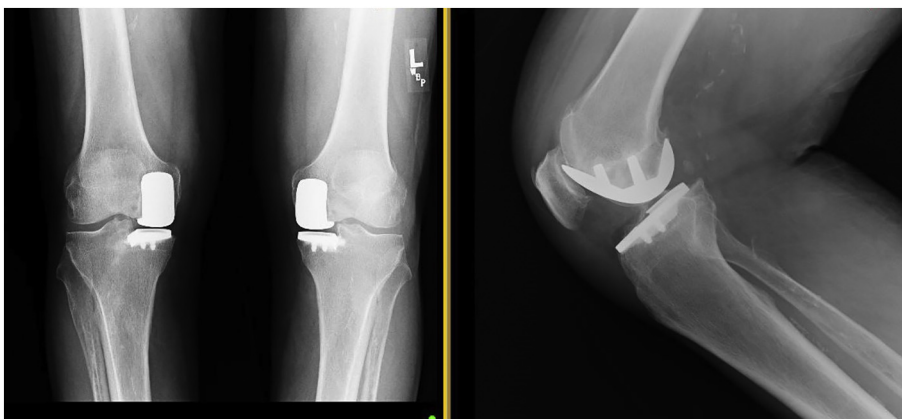
Figure 2. Post-operative radiographs following primary right unicompartmental arthroplasty.
