Failure analysis of a safety equipment exposed to EAF environment

A. Lanzutti*, M. Magnan, S. Maschio, L. Fedrizzi

University of Udine, Polytechnic Department of Engineering and Architecture, via delle scienze 208, 33100 Udine, Italy

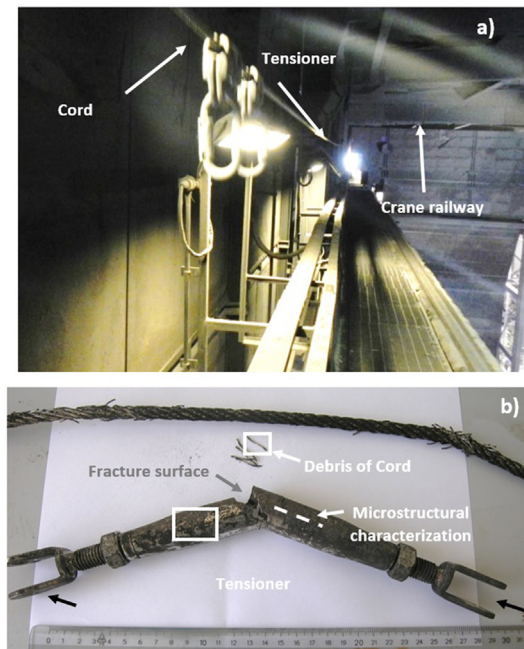
In the present work, the failure of a safety system for the inspection of a crane installed to load an Electric Arc Furnace (EAF) has been investigated (Fig. 1a). This system is also made of cords and tensioners giving a sort of stiffness to the structure. The cords are strands of AISI 316 stainless steel wires cold drawn, while the tensioner is an AISI 316 hot stamped component that has been machined after the stamping process.

Fig. 1. image of the safety system, a) as installed in the steel making plant (the tensioner position is indicated in the picture) and b) the broken components (tensioner + cord). The squares indicate the regions of top view SEM analysis. The dotted line indicates the section for the microstructural analysis. The black arrows indicate the regions of cord-tensioner connection.

Unexpectedly, the components studied in this experience already failed after a service life of about 2 months instead of a foreseen life of more than 3 years. As the components were yearly inspected to guarantee a safe use of the system, the failure was noted because some tensioners presented showy cracks and the cord showed a progressive detachment of some wires of the strand. It is to remark that the tensioner did not show a complete failure but only a deep crack inducing a not correct movement the system. On the other hand, it is likely that some small wires of the cord failed before the tensioner, because of the different dimension of the components.
