## Case study

# Investigation of a naturally patinated bronze artifact originating from the outdoor statuary group of Mathias Rex

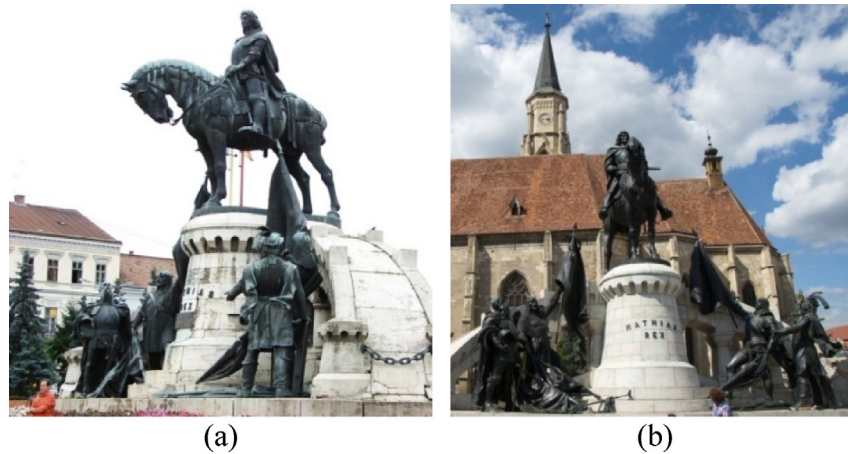
The King Matthias statuary group was exposed outdoors under atmospheric corrosion and, because of increasing pollution in recent years the monument was subjected to an acceleration of corrosion and depreciation in appearance. The artistic aspect was

also suffering due to the appearance of leaks, discoloration and the crystallization of impurities on the bronze surface. Accumulations of secondary genesis minerals and oxidations were also identified. But the most serious depigmentation and corrosion of this outdoor monument occurred as the result of pollutant agents: exhaust gas, settled dust, calcified dust and deposition of aerosol particles, characteristic to urban atmosphere.

Fig. 1. Matthias Rex statuary group, Cluj-Napoca, Romania: a: before restoration; b: after restoration.

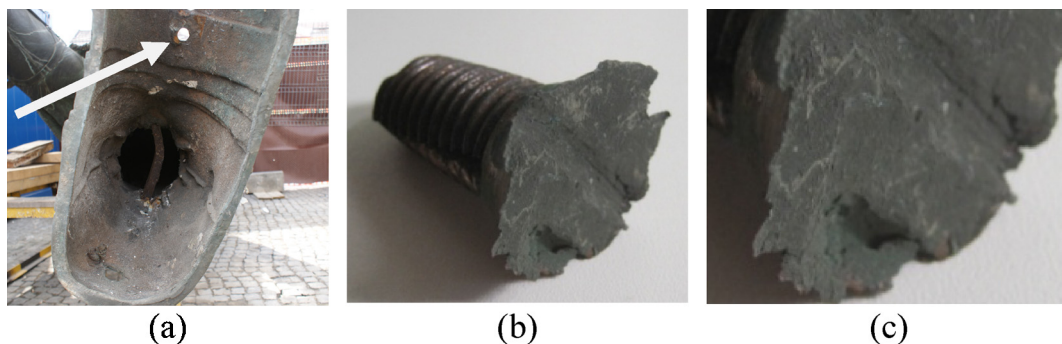
The ten bronze screws investigated in this study were used to assemble the Mathias statuary group and were collected during restoration of the monument in 2010 and analyzed immediately after. They were used to fix the feet of the four bronze characters positioned on the pedestal platform. The spot where the screws were originally placed on the statue group is shown on Fig. 2a. The bronze screws are covered with natural patina formed during 100 years in urban atmosphere of Cluj-Napoca, Romania. Because their advanced stage of degradation (Fig. 2b–c) they could not be reused in statue restoration. Based on optical microscopy observations, it could be noticed that the screws degradation occurred with destruction of the original surface, also with the grain boundary corrosion appearance, which finally leads to alloy embrittlement

The screw surface is colored in gray, brown, and dark green, in concordance with the characteristic bronze patina color [1].

Fig. 2. Bronze screw from Matthias Rex statuary group: a: the original place of the screw; b: the bronze screw; c: details of the screw.
