# The church of Saint Martin (Trujillo, Spain): Study of the stone degradation

Fátima Arroyo\*, Rosario Villegas-Sánchez

School of Engineering (University of Seville), Camino de los Descubrimientos s/n, 41092 Seville, Spain

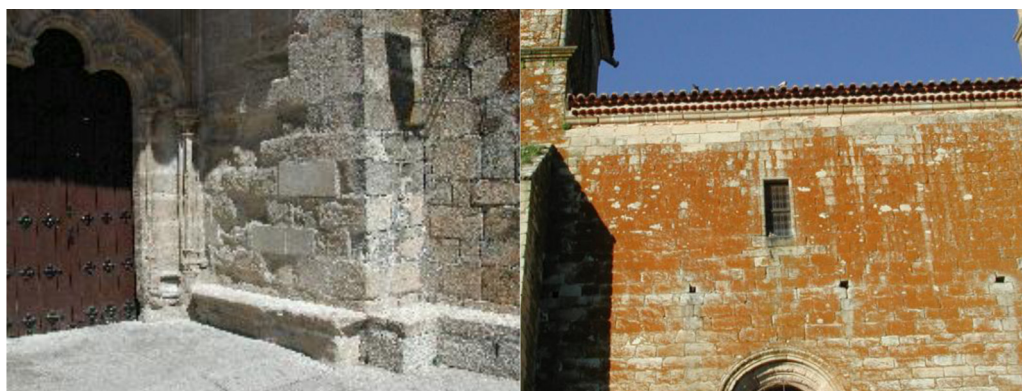
Although visual inspection of the building showed a good conservation state, the following deterioration factors were detected in some areas (Fig. 2):

- the most important deterioration indicator is grain disgregation due to the combined effect of dampness and salt-rich mortars;
- there are exfoliations and contour spalling, pitting in wet and windy areas and some crater formation related to grain disgregation;
- there are damages due to freezing in wet areas;

- spalling is related to the grain disgregation and to temperature changes in elements with high surfaces exposed to air. There are big fissures due to mechanical actions and syismicity;
- there are a lot of efflorescences due to the mortars used in repair and restoration works;
- biological factors (algae, lichens and plants).

Fig. 2. Deterioration factors present in stone.
