# The roof of the Church of the Nativity in Bethlehem: Structural problems and intervention techniques

In the present paper, the roof of the Church of the Nativity in Bethlehem is investigated. The lack of maintenance for many years has determined a copious infiltration of rainwater causing serious damage to the wooden structural elements. The damage, both on the main trusses and on the secondary structure, is first analyzed. Then, the stress state is checked on the basis of the surveyed damage. Finally, an intervention of restoration is designed in order to recover the damaged parts and to increase the seismic strength of the entire structure.

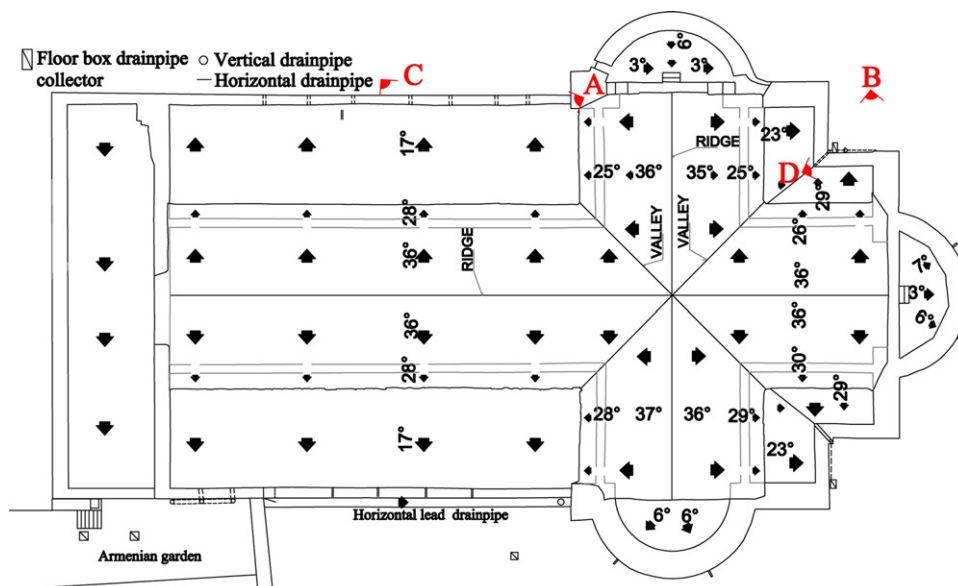
boards as well as some parts of the masonry walls. In Fig. 3, the slopes of the different zones of the roof, the horizontal and vertical pipes collecting the rainwater and some viewpoints of the photos taken (A, B, C illustrated in Fig. 4 and D illustrated in Fig. 5) are depicted. The rainwater is mainly collected by a system of horizontal pipes located along the longitudinal walls of the Church and by two vertical pipes located at each apse-transept corner.

Fig. 3. Roof slopes, drainpipes and photo viewpoints.
