Investigation of failure of high voltage bushing at power transformer

In this paper, bushing-breakdown was identified as one of the main causes of transformer failure that resulted in a fire outbreak in July 2015 at the Gadong Power Station, Brunei Darussalam. To perform the investigation, three specimens from the burnt pieces were collected, which were white ash, bushing housing ashes and solid remnants from the burnt site. Both JSM-610F FIELD Emission Scanning Electron Microscope (SEM) and Energy Dispersive X-ray Spectroscopy (EDS) were used to obtain the electron images, and to analyze the types of elements present in the specimens. In addition, software simulations for the high voltage bushing failure were carried out using COMSOL Multiphysics Software for different oil levels, and the obtained results have been summarized. Finally, it is comprehended that fire outbreak happened due to leaking of the insulating oil in the high voltage bushing and loose tighten of the sealing part of the cable termination boxes.

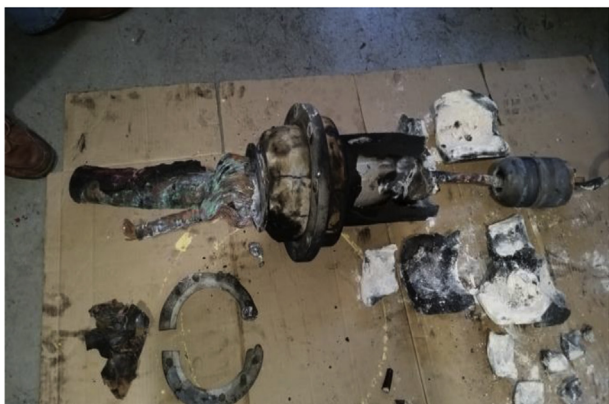
In July 2015, a fire broke-out in one of the Power Stations in Brunei Darussalam. Immediately after the fire incident, an external inspection was carried out, which confirmed that the insulating oil was leaking in the B-phase HV cable box where the fire initiated at the top end of the stress cone and the top part of the bushing. As a result, the top section of the cast resin housing fragmented into several pieces as shown in Fig. 1. The insulation on the XLPE cables at the location of the fire breakout disintegrated and white ash was found on the broken housing. The possible fire breakout was identified to be the top part of the bushing, cable termination and oil contamination. At that point, to validate the external findings, and to identify the cause of the fire, a thorough scientific investigation was called for. This paper presents different steps taken during the investigation, and the pertinent findings of this study.

Fig. 1. Broken parts of B-phase HV cable termination and bushing.

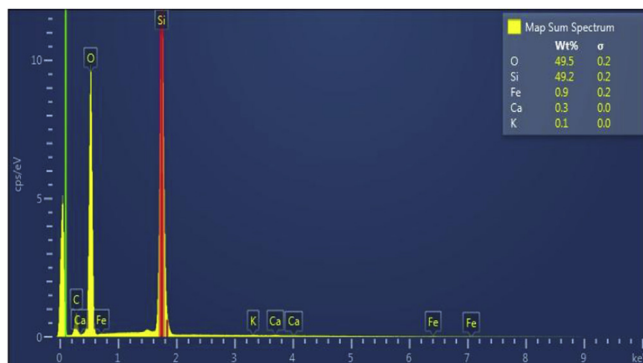
Fig. 3. Map sum spectrum analysis of scanned specimen.

Green, blue and red colors on the electron images identify Silicon (Si), Carbon (C) and Oxygen (O) elements, respectively. Fig. 3 represents spectral analysis of elements that are identified in the scanned images, obtained with the aid of EDS. The result obtained from the analysis indicates that the white ash specimen consists of higher percentage of Si (49.2%) and O (49.5%). This analysis was then confirmed by the observation of the specimen taken from the part of the burnt bushing. Later observation suggests that the compound silicon dioxide (SiO_2) belongs to the silicone-rubber stress cone of the high voltage bushing [10].

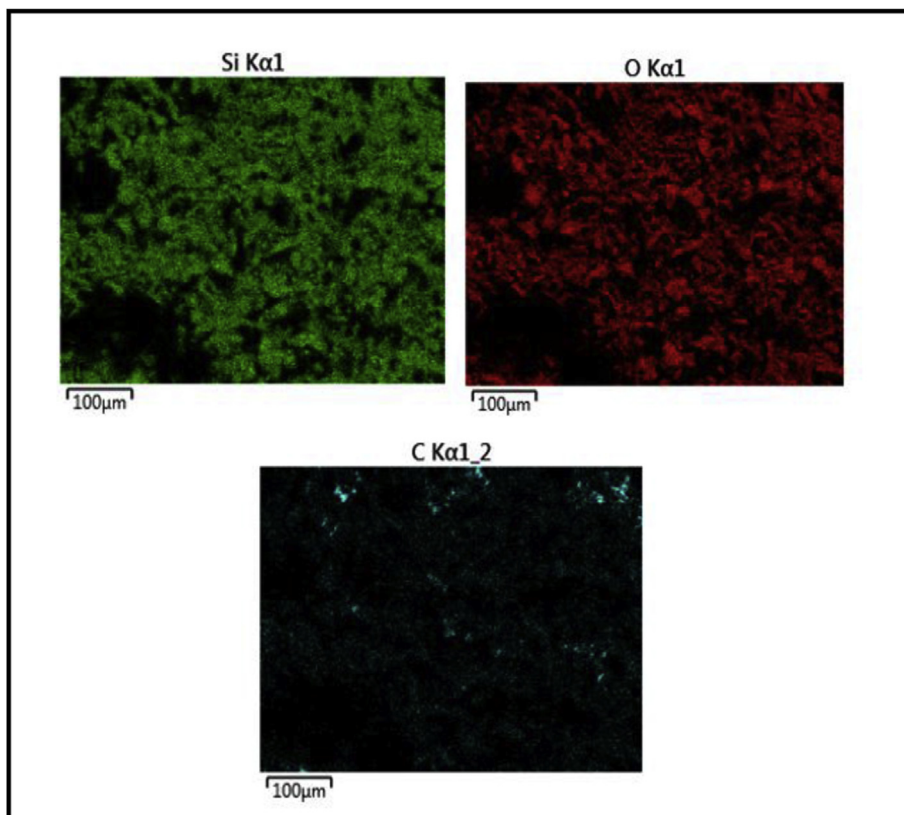
Specimen I-White Ash: The electron images of the white-ash specimen, are shown in Fig. 2. The presence of different elements in the specimen is distinguished by observing the difference in colors on the electron images.

Fig. 2. EDS mapping image of white ash specimen constitutes of three main elements Si, O and C.
