## Cracking in cargo aircraft main landing gear truck beams due to abusive grinding following chromium plating

Noam Eliaz<sup>a,\*</sup>, Haim Sheinkopf<sup>b</sup>, Gil Shemesh<sup>b</sup>, Hillel Artzi<sup>b</sup>

Accepted 10 October 2004

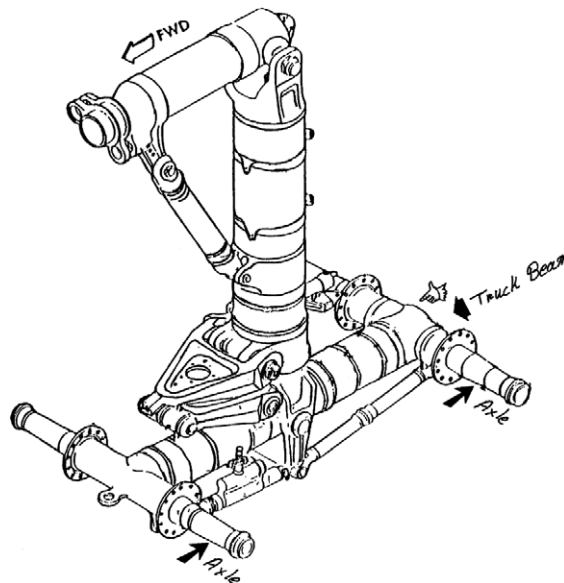
Fig. 1. Illustration of the main landing gear assembly on the subject aircraft. A finger marks the region of failure.
