High temperature corrosion of a thermowell in an incineration plant

R.C. Yin *, A.A. Al-Refaie, B. Al-Yami, A.K. Bairamov

Materials and Corrosion Section, Sabic Technology Center, P.O. Box #11669, Jubail Industrial City 31961, Saudi Arabia

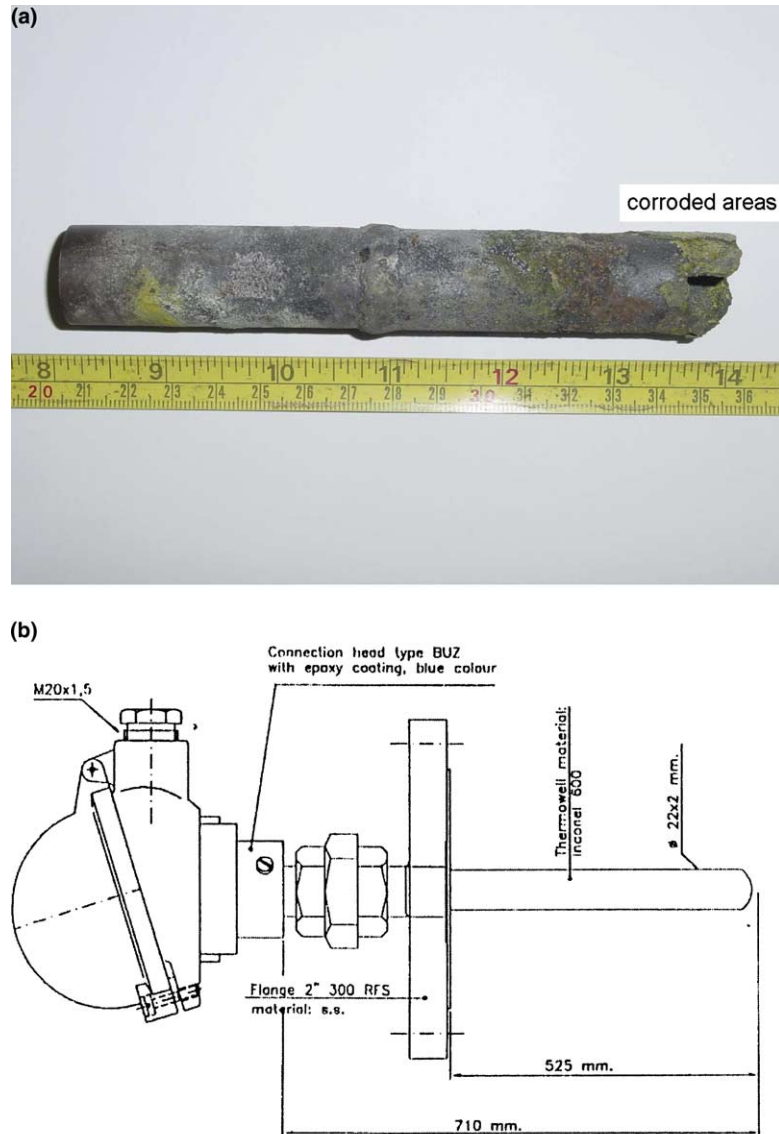
The thermowell inside the post combustion chamber in an incineration plant failed due to severe high temperature oxidation. The failure was caused by deep intergranular oxidation attack and surface scaling of the component. The intergranular oxidation attack is more damaging to the material integrity. Inconel 600 was improperly used as the thermowell material due to insufficient Cr content for formation of a continuous protective Cr_2O_3 layer on the alloy surface, and the high operating temperature 950 °C nearly approaching its upper temperature limit (1000 °C). Replacement of Inconel 600 by more corrosion- and heat-resistant materials is strongly recommended.

Within 6 months of service in an incineration plant of Saudi Arabia, the thermowell (Fig. 1) suffered catastrophic high temperature damages at the top end, exposing the thermocouple to the hot service PTA slurry (purified terephthalic acid – 16% acetic acid, 0.1% Co, 0.4% Mn, 0.5% Br, 30% H_2O , 25% solids, and 28% PTA. pH: 3–3.5) and CDR wastes (closed drain wastes – acetic acid traces, 0.1% H_2O , and 99.8% organics). Consequently, the service damaged the thermocouple resulting in loss of temperature indication. The wastes are fed through the rotary kiln, burnt inside the post combustion chamber (Fig. 2), and carried away through the flue gas duct outlet (gases) and the slag conveyer (slags). The thermowell measures 525 mm (length) \times \varnothing 22 mm (OD) \times 2–3 mm (thickness), about 2.5 cm long portion of the thermowell was exposed inside the post combustion chamber. The construction material of the thermowell is Inconel 600

Fig. 1. (a) Photo of the failed thermowell. (b) Design specifications of the thermowell.
