## Analysis of an unusual crankshaft failure

A crankshaft cracked in a strange manner when test running was performed for only 20 min. Four cracks were found on the edge of the oil hole. Using mechanical analysis, microstructure and metallurgy the reason of this event has been revealed. Force of friction caused by improper crankshaft repair and assembling is main factor of the failure. Why friction occurs, how the crack initiates and expands and what the process of failure is were studied.

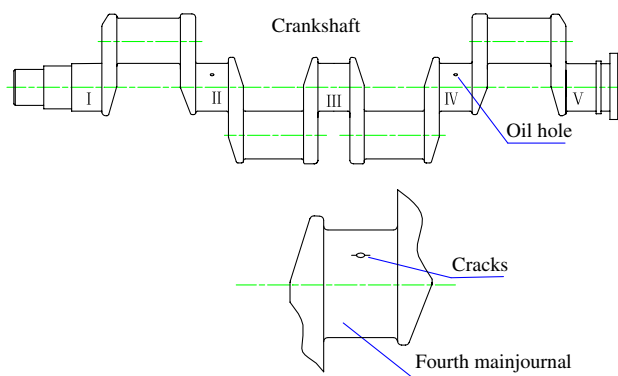
The failure shaft is a new crankshaft; model RD8T, on a bulldozer TCM-175B. After a crankcase repair process it was assembled to the engine and began test running without any loads. An unusual noise arose and the test was stopped automatically 20 min later. Disassembly detection was performed and four cracks were found on the fourth main journal. All of them were located on the edge of oil hole (Fig. 1). The lengths of the cracks were 6–9 mm. Main bush was destroyed seriously (Fig. 2). The copper on inside of bush was almost torn off totally. Only a little copper was stuck on the surface of shaft and bush randomly. The color of the surface of main journal was dim and there were blue and black circle zones crossed with cracks. No other damage can be seen by naked eye.

Fig. 1. Schematic illustration of crankshaft and cracks on the fourth main journal.

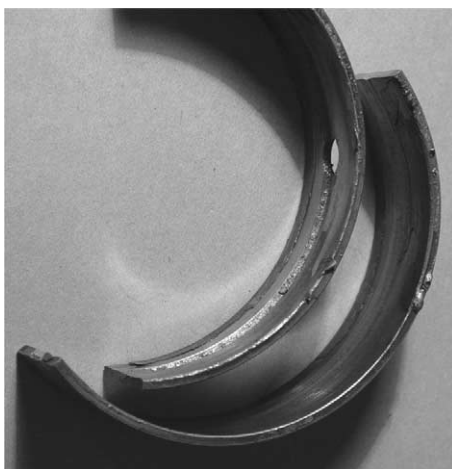
Fig. 2. Damaged main bush.
