# Failure analysis of nickel 200 sintered filter cartridges

C.R.F. Azevedo \*

*Laboratory for Failure Analysis, Instituto de Pesquisas Tecnológicas do Estado de São Paulo, P.O. Box 0141,  
01064-970 São Paulo, Brazil*

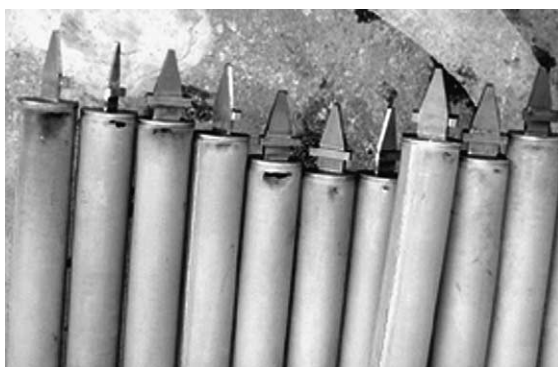
The premature failure of nickel 200 sintered filter cartridges used to separate the solid catalytic particles has been investigated. The failure is due to the formation of holes and transversal cracks, which occur preferentially on the upper part of the cartridges, near the welding. Microstructural and fractographic characterisation indicated that the failure started on the internal surface of the cartridges, which presented intense secondary intergranular cracking associated with corrosive attack. Fractographic examination on the surface of the transversal crack near the external surface indicated the action of a ductile intergranular fracture mechanism, while near the internal surface it featured a faceted and jagged topography, with cracks propagating inter and transgranularly. The results suggested that the premature of the cartridge failure was promoted by an environmental-assisted mechanism (stress corrosion or hydrogen embrittlement).

Fig. 2. Location of the defects near the top of the sintered cartridges.
