## Post-earthquake diagnostic investigation of a historic masonry tower

### Antonella Saisi<sup>a,b</sup>, Carmelo Gentile<sup>a,b,\*</sup>

The paper describes the methodology applied to assess the state of preservation of the tallest historic tower in Mantua, the Gabbia Tower, after the Italian earthquakes of May 2012. An extensive experimental programme – including geometric survey, visual inspections, ambient vibration tests, sonic and flat-jack tests – has been planned and carried out to support the future preservation actions of the tower. The paper focuses especially on the outcomes of on-site survey and dynamic tests and highlights the effectiveness of integrating the information obtained from these tests to assess the structural condition and seismic vulnerability of the tower. The adopted experimental methodology, generally suitable as a prompt diagnostic procedure, successfully detected the local vulnerabilities as well as the overall state of preservation of the tower and addressed the subsequent monitoring phase.

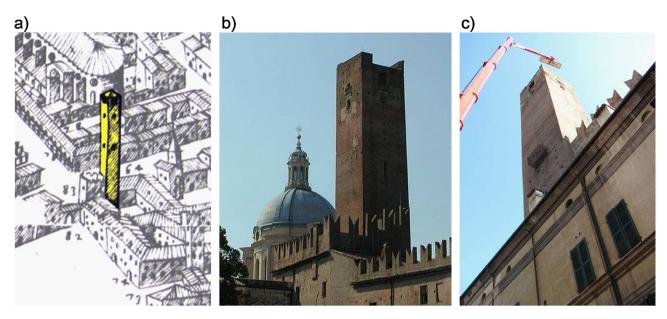
The paper presents the main results of a recent post-earthquake assessment of a masonry tower. The investigated tower (Fig. 1), about 54.0 m high and dating back to the XII century, is known as Gabbia Tower [18,19] and is the tallest tower in Mantua, Italy. The tower is a symbol of the Cultural Heritage in Mantua so that the fall of small masonry pieces from its upper part, reported during the

Fig. 1. The Gabbia Tower in Mantua, Italy. a: view of the XVII century [15]; b: recent view; c: view during the inspection (31/07/2012).
