Neorenaissance/Neobaroque stained glass windows from Madrid: a characterisation study on some panels signed by the *Maumejean Frères* company

Manuel García-Heras ^{a,*}, Noemí Carmona ^b, Cristina Gil ^c, María Angeles Villegas ^a

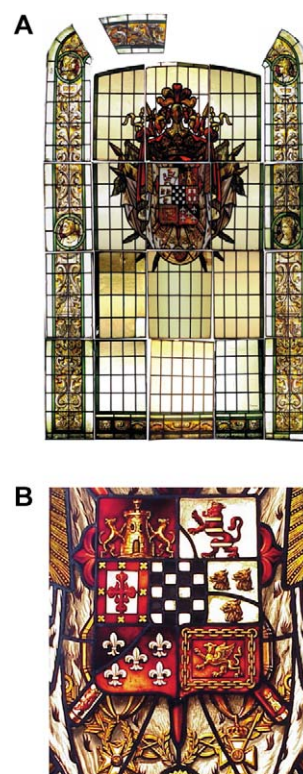
Each floor has three panels which follow the same scheme in their composition: a main central panel with two lateral ones. All of them are fitted to rectangular windows of 2 m in width and 3 m in height. The central ones used to have rounded corners in their upper parts. On the whole, they presented a poor state of conservation extended to most of their materials because the buildings were unoccupied for a long time. The best preserved panels were found on the second floor. The main panel was composed of a central heraldic coat of arms surrounded by borders of geometric designs (Fig. 1A). Either the central motif or the borders were profusely decorated using both glasses and grisailles of different colours (Fig. 1B). The lateral panels were also surrounded by borders of geometric designs, even though only small floral designs were placed on its centre. Red, blue, green, yellow, and white-greenish glasses were used for manufacturing these stained glass windows. The good conservation conditions shown by the second floor panels allowed the reconstruction of those located in other floors, assuming that some lateral panels were repeated.

Fig. 1. Central stained glass window panel located on the second floor of the building sited at the 19–21 Marqués de Cubas street in Madrid, as received in the laboratory after dismantling. Both images were obtained using transmitted light. (A) General view. (B) Detail of the central coat of arms.
