# Effect of periodic in situ deposition of silica layer on the long term operation of a micro-gas turbine

Min Tae Kim\*, Doo Soo Kim

Power Generation Laboratory, Korea Electric Power Research Institute, Daejeon 305-308, Republic of Korea

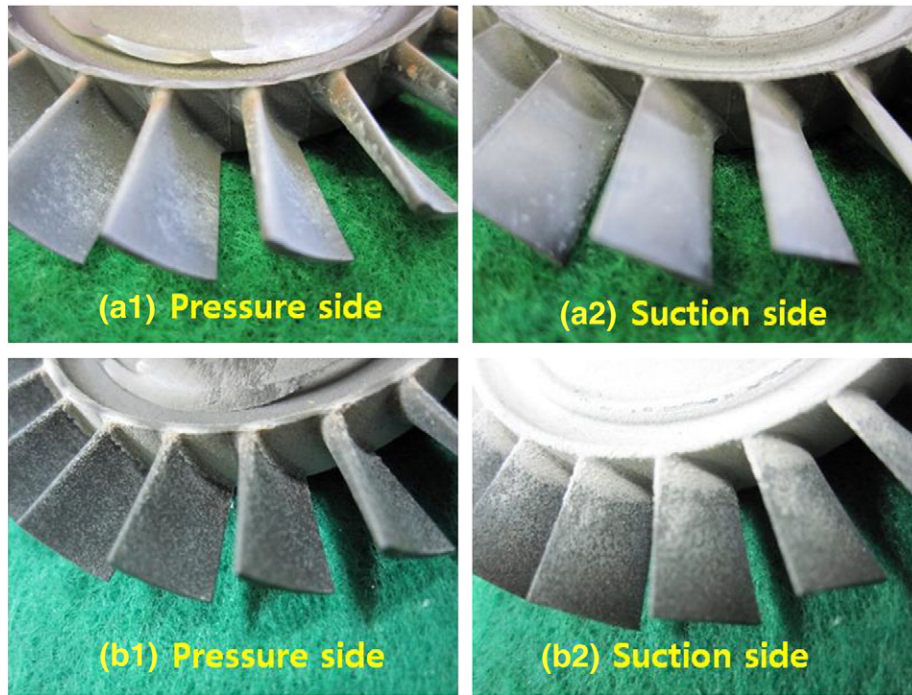
Fig. 1. Macro-images of the C1 blades after (a) 30 cycles and (b) 120 cycles.

Fig. 1 shows macro-images of the C1 turbine blades under testing (30 cycles, Fig. 1a) and after the test (120 cycles, Fig. 1b), respectively.

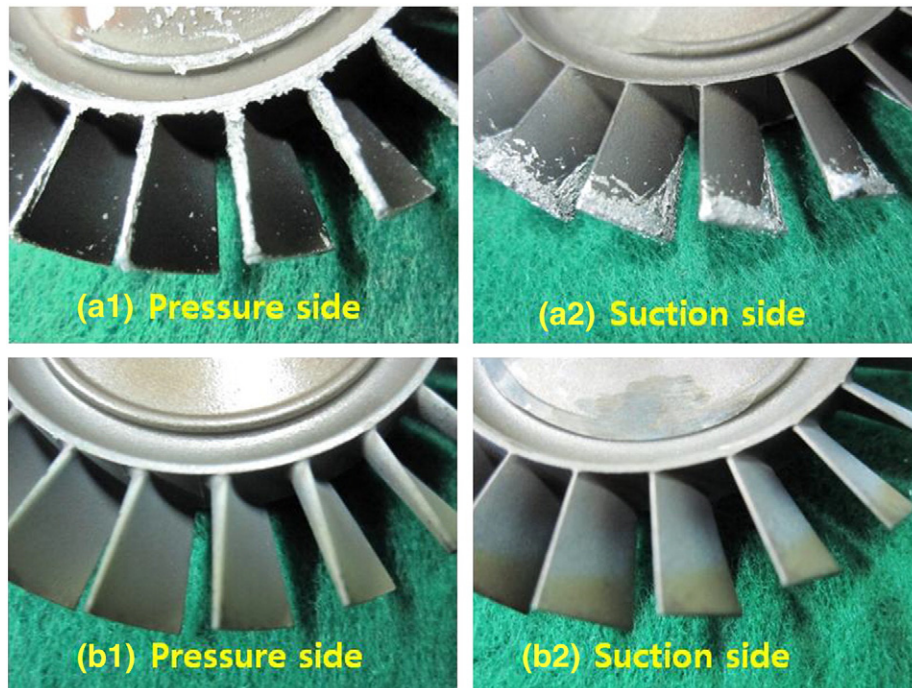
Fig. 2. Macro-images of (a) the C2 blades after 59 cycles and (b) the C3 blades after 120 cycles.
