Engineering Failure Analysis

Failure analysis of the balance ball pin in the car steering system

Ruidong Guo, Song Xue*, Ailin Deng

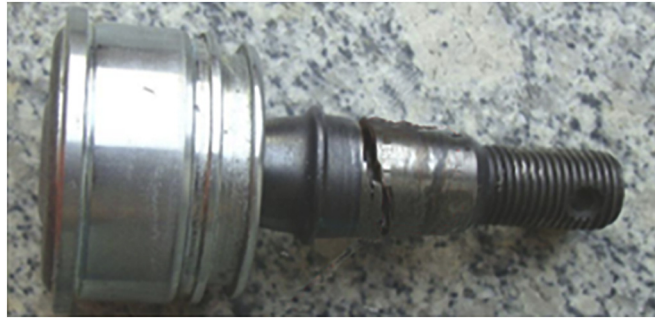
Fig. 1. Fractured balance ball pin.

The cracked balance ball pin is shown in Fig. 1. The global assembly relation of the transverse stabilizer bar, the link rod and the balance ball pin is shown in Fig. 2(a) and (b). A ball pin consists of a threaded part and a fitting part. The balance ball pin is mainly subject to fluctuations load. Failure took place in the middle part which is made of 40Cr steel with a diameter of 18 mm. And this material is a mature material, which is widely used in automotive connectors. After quenching on the ball pin surface, the surface has higher hardness [7].
