# Failure analysis of handhole flange cracking

Yuan Zhang<sup>a</sup>, Xiandong Shang<sup>b</sup>, Mingda Song<sup>b</sup>, Zhiwei Sun<sup>a</sup>, Shugen Xu<sup>a,\*</sup>

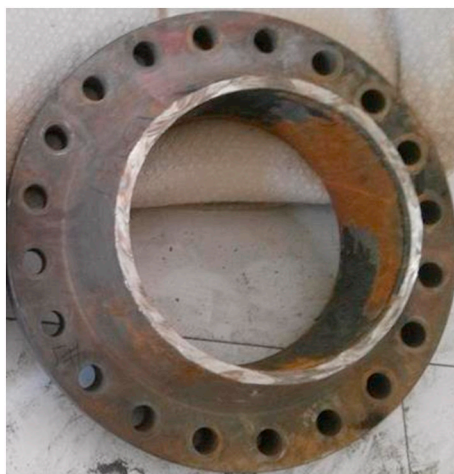
Fig. 1. The appearance of the handhole flange.

The handhole flange of a heating furnace radiant chamber cracked in May 2016. The failure of the flange affected the normal operation, and the failure analysis was essential. As shown in Fig. 1, the flange is classified as welding neck flange.

According to the information examined, the flange was produced according to the standards of ASME II A2010ED + SA182M and HG/T 20615-2009A, and the material is SA182-F347H steel. The specification is WN350-300RF S = 11.13. The flange operated at 625 °C with atmosphere rich of hydrogen oxygen, nitrogen, methane, ethane, and etc.

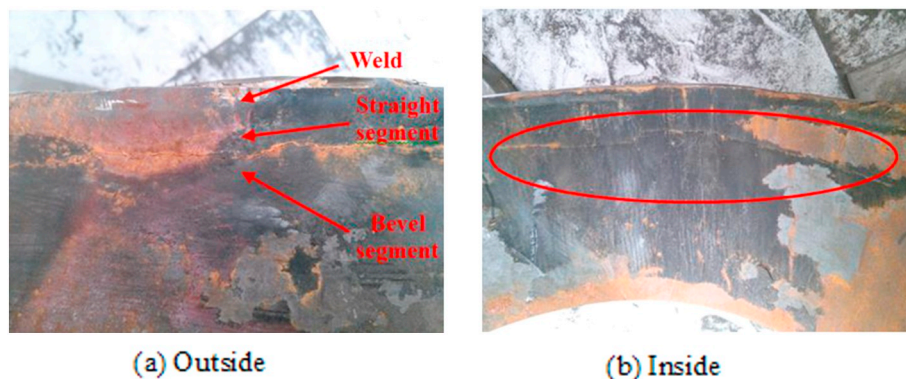
As shown in Fig. 2, the penetrating circular cracks are located in the flange side heat affected zone and the transition area of the straight side and the hypotenuse. The inside and outside of the crack part are covered with black layer, and no plastic deformation occurred.

Fig. 2. The circular crack morphology.
