Exploitation of Laser Voltage techniques for identification and complete characterization of a scan chain transition fail issue using the second harmonic approach

Emanuele Villa^{a,*}, Audrey Garnier^a, Antoine Reverdy^b

^a STMicroelectronics, Italy

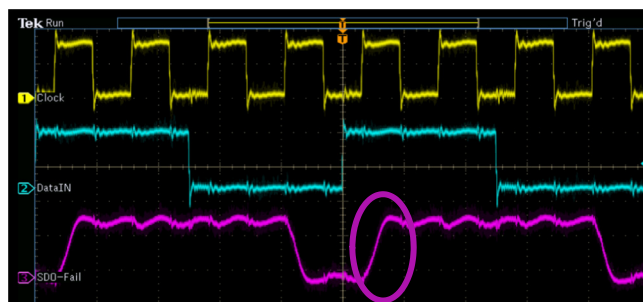
The electrical analysis performed through Actual Mode approach on the ATE showed an anomalous reading of the “pattern 0”, while emulating the scan chain in serial mode with a classical “0011” periodic signal. During reading, an anomalous “L-H-H-H” was measured, which differs from the expected “L-L-H-H” signal.

This type of failure mode could be modelled by a “fast-to-rise” fault model, where the data latched by the flip-flop seems to change in advance with respect to the latching clock.

The modified scan pattern was run on the failing sample and the failure mode confirmed. Resulting waveforms are presented in Fig. 1.

Fig. 1. – Data IN (Scan In) signal (Blue), SDO (scan-out) improperly latched on the second clock pulse of the period (pink circle), Clock signal (Yellow). (For interpretation of the references to colour in this figure legend, the reader is referred to the web version of this article.)
