Failure analysis on 14 nm FinFET devices with ESD CDM failure

C. Shaalini, P.K. Tan*, Y.Z. Zhao, B.H. Liu, Y.Z. Ma, A. Quah, Y.L. Pan, H. Tan, Z.H. Mai

Globalfoundries Singapore Pte, Ltd, 60 Woodlands Industrial Park D Street 2, 738406, Singapore

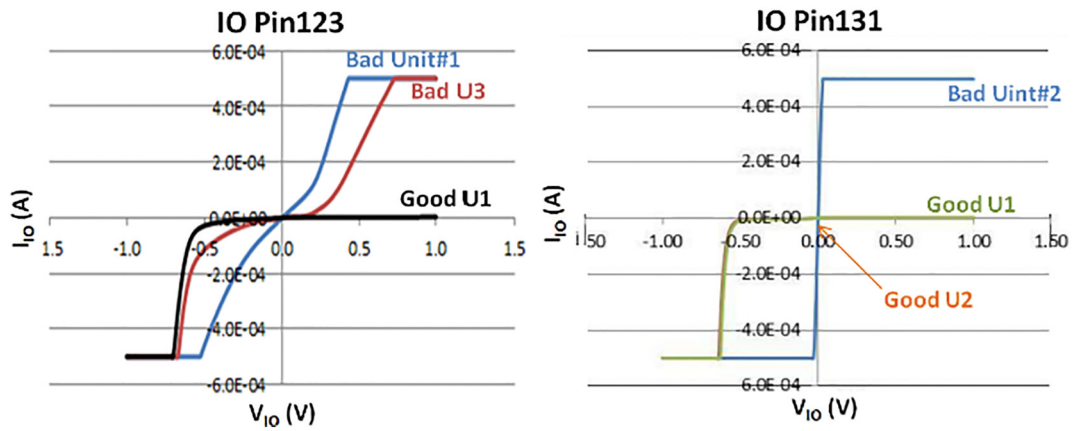
A few package units were returned from customer site for FA after ESD CDM Qualification (QUAL) failure, those package has failed early stage voltage stress (< 100 V). The failure symptom is high leakage on input-output (IO) pins of ESD circuit for all failed units. Fig. 1 shows the current-voltage (IV) measurement on 1st, 2nd, and 3rd bad units. The IV results show high leakage on bad Unit#1 IO Pin 123 and Ohmic short on bad Unit#2 IO pin 131 compared with good dies. The packages were polished to die backside level to perform Electrical Failure Analysis (EFA) fault isolation with Thermally Induced Voltage Alternation (TIVA) analysis. TIVA analysis is one of the commonly used EFA technique to locate the leaky path by irradiating infra-red (IR) laser to a biased IC. Optical power from the laser is converted to thermal energy on conductive material and induces resistivity variation.

Fig. 1. IV measurement of IO pin that have leakage on Good and bad dies.

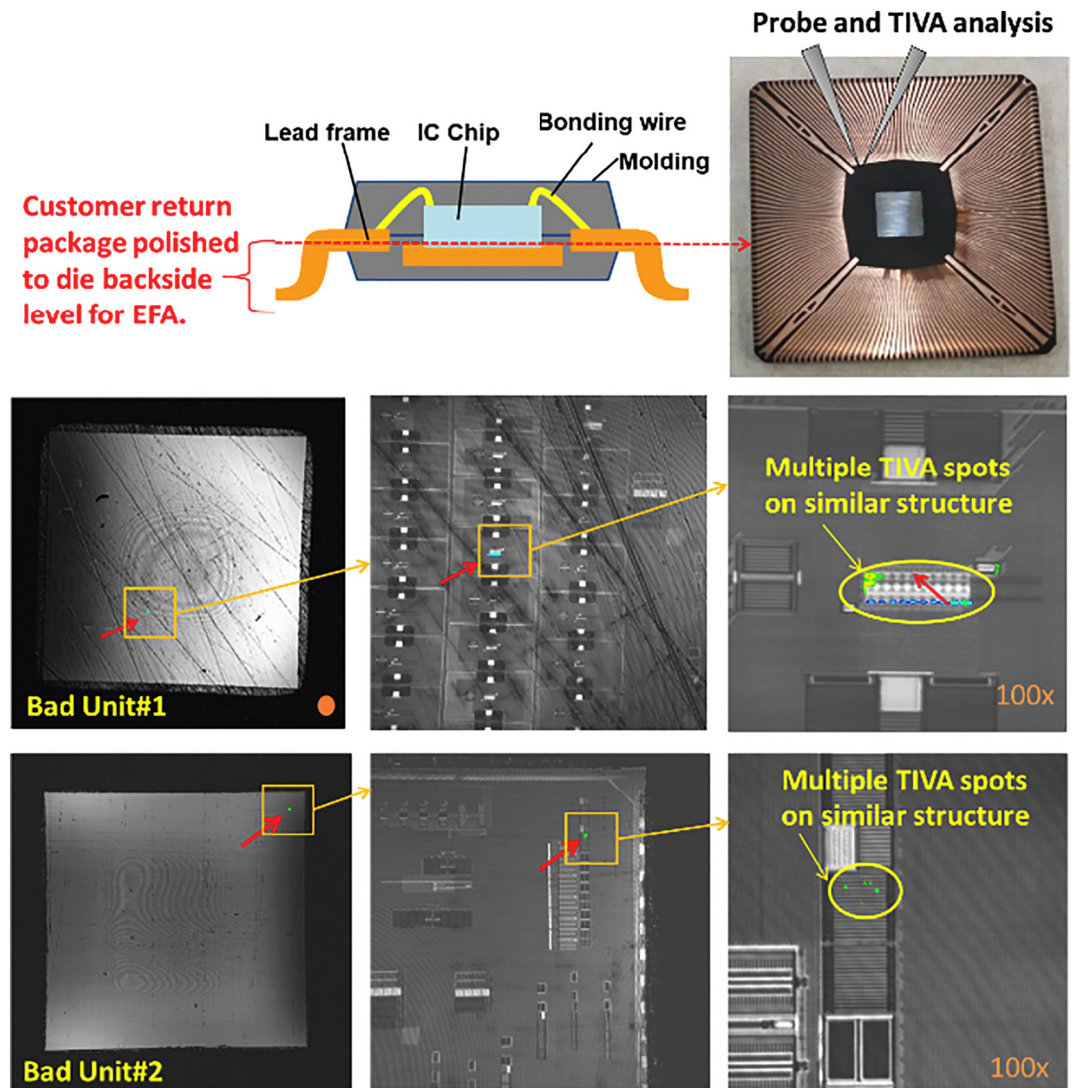
Fig. 2. TIVA result on polished package for short/leakage failure, Unit#1 and Unit#2.
