Engineering Failure Analysis

Failure analysis of spring of hydraulic operated valve

Urbi Pal*, Goutam Mukhopadhyay, Sandip Bhattacharya

Failure Analysis Group, R&D and Scientific Services, Tata Steel, Jamshedpur 831001, India

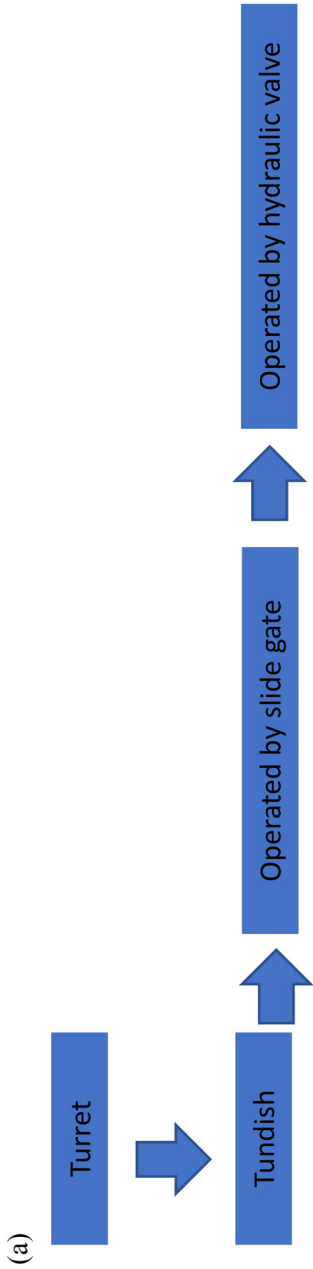
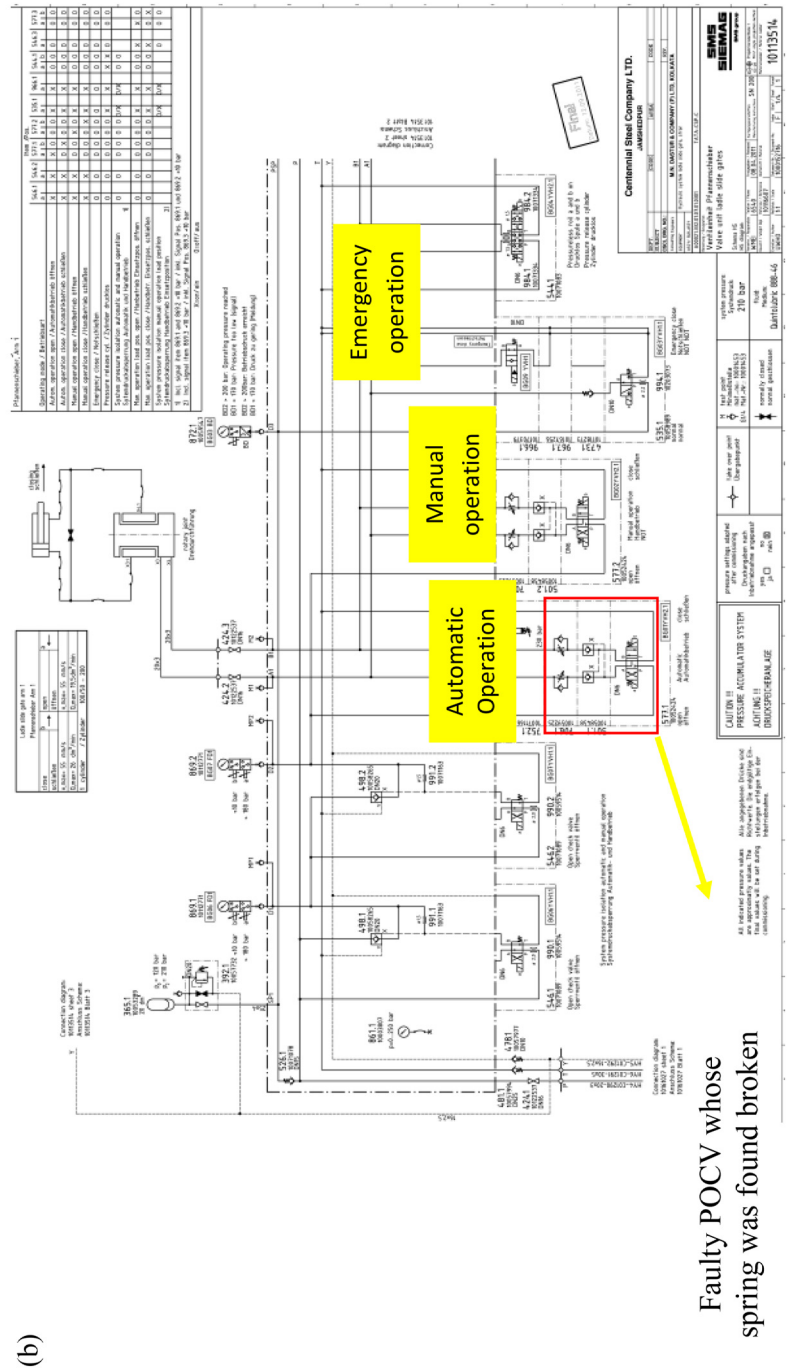
Fig. 1. (a) Flow diagram of Hydraulic Slide gate (b) Location of faulty valve in the circuit diagram.
