# Engineering Failure Analysis

## Stress corrosion cracking and brittle failure in a fiber-reinforced plastic (FRP) insulator from a 400 kV transmission line in humid environment

D. Luder\*, S. Ariely, M. Yalin

Materials Lab, Israel Electric Corporation, Nativ Ha'or 1, Haifa 3100001, Israel

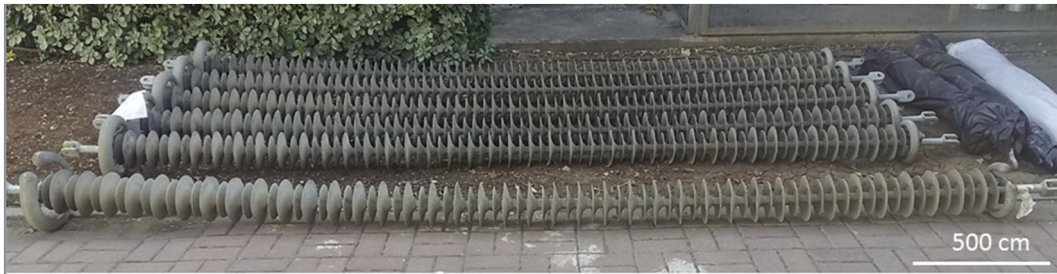
Fig. 1. 400 kV composite insulators (Reliable corp.)

The following work presents the failure analysis of a composite fiber-reinforced plastic (FRP) suspension insulator. The insulator was vertically installed on a 400kV transmission line along the humid south Israeli coastline (average: ~70% RH) Fig. 1. The insulator had a declared life expectancy of 30 years and failed after 15 years in service. The failure caused a temporary local outage at a high cost. An investigation was commissioned to find the root cause of the failure (RCA). The insulator has a length of 4 m, includes 75 weather-sheds with alternating diameters of 169 and 137 mm, two grading rings with diameters of 210 and 310 mm and two metal connectors/ fittings at each side of the insulator, Fig. 2. The rod core of the insulator is composed of FRP, and is housed with a silicon rubber (SiR) protection layer which is also the material composing the weather-sheds. The rod diameter including housing is 30.3 mm. The metal fitting is connected to the FRP rod via crimping, Fig. 2.

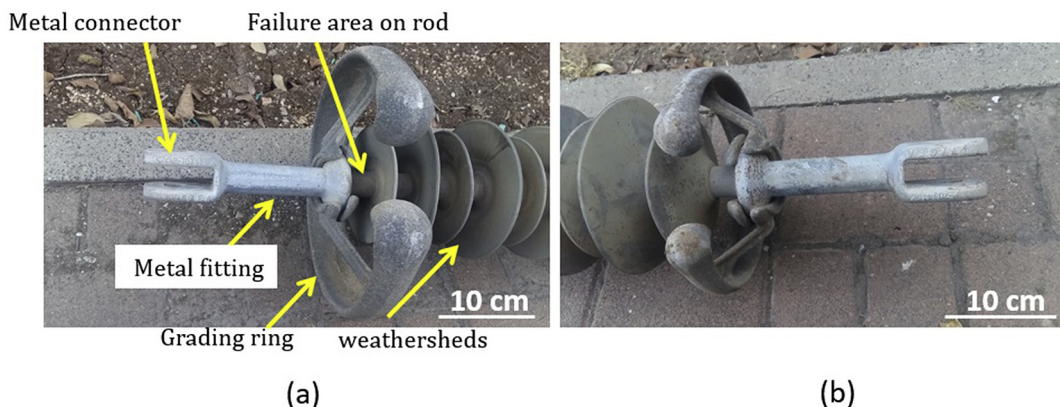
Fig. 2. (a) insulator end with long-diameter grading ring (b) insulator end with short-diameter grading ring.
