Exploratory survey of initial image quality in new digital mammography units prior to use in patients in Mexico

E. Gaona^{a,*}, T. Rivera^b, N. Molina-Frechero^a, J.G. Franco^a

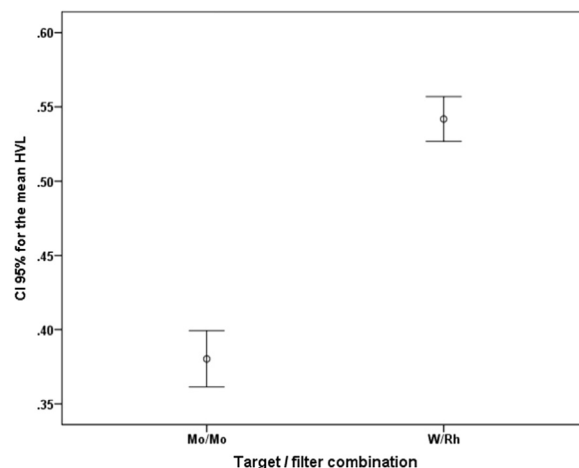
Fig. 1. Shows the distribution of the HVL depending on the type of target /filter combination, CI 95%.

The study results found that the accuracy of the kVp is $2.93\% \pm 0.48$ and coefficient of variation < 0.02 for Mo/Mo combination and for W/Rh $2.66\% \pm 0.51$ (coefficient of variation < 0.02). W/Rh combination has higher HVL (Fig. 1) and it has a higher X-ray beam quality with greater penetration of x-ray beam into tissue and greater efficiency of the digital image detector and reduction of Average Glandular Dose (Fig. 2). Measurements of the half-value layer (HVL) was $= 0.38 \text{ mm Al} \pm 0.02$ at 30 kVp for Mo/Mo combination and HVL $= 0.54 \text{ mm Al} \pm 0.01$ at 30 kVp for W/Rh. Other authors found HVL values with a mean of $0.33 \text{ mm Al} \pm 0.04$ for the Mo /Mo combination at 28 kVp (Sharma et al., 2012).
