Excessive groundwater inflow during TBM tunneling in limestone formation

Sungjune Lee^a, Joon-Shik Moon^{b,*}

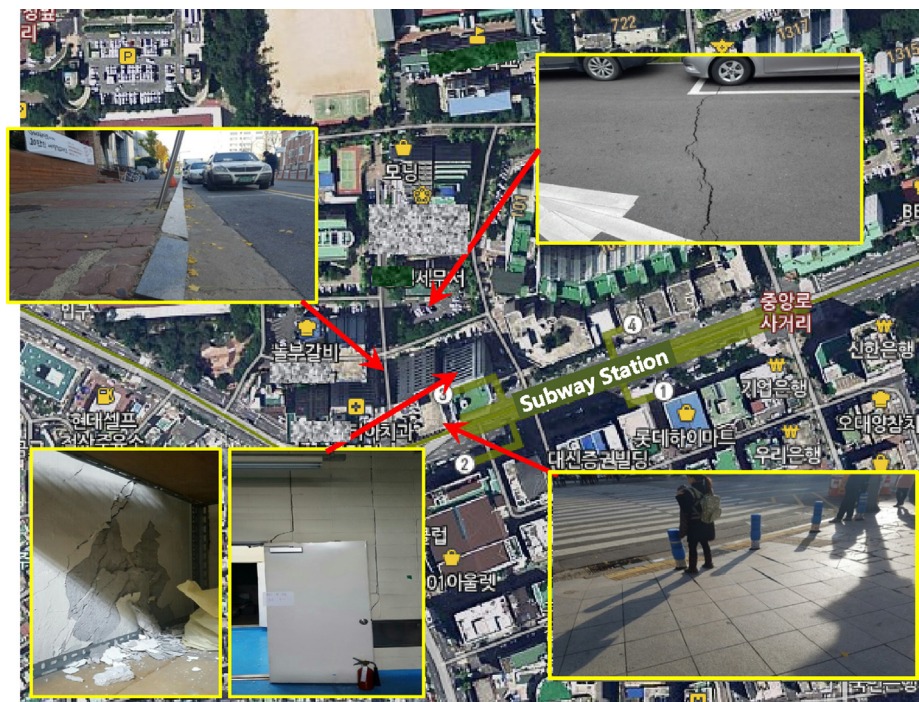
In this case study, excess groundwater inflow was drained through the tunnel face in fractured limestone formation with cavities during the 1873 m-long cable tunnel excavation in at about GL-50 m depth. The initial groundwater level of GL-16 m was dropped to GL-32 m, and ground subsidence and damage of adjacent buildings were reported. Fig. 1 shows some pictures of building damages and subsidence of roads near NO.34 + 16 where EPBM experienced high water inflow rate.

Fig. 1. Ground settlement due to excessive water inflow during tunneling.
