Fractographic ceramic failure analysis using the replica technique

Susanne S. Scherrer^{a,*}, Janet B. Quinn^b, George D. Quinn^c, H.W. Anselm Wiskott^a

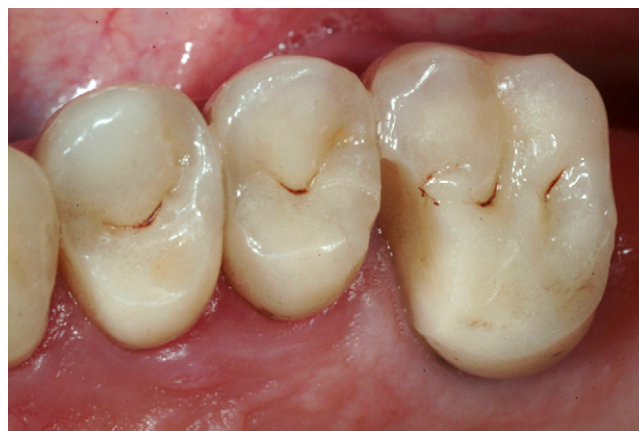
Fig. 1 – Fracture of the veneering porcelain (AllCeram) of an upper left Procera Alumina Molar after 4.2 years of intra-oral function.
