Thaumasite formation in a tunnel of Bapanxia Dam in Western China

Abstract

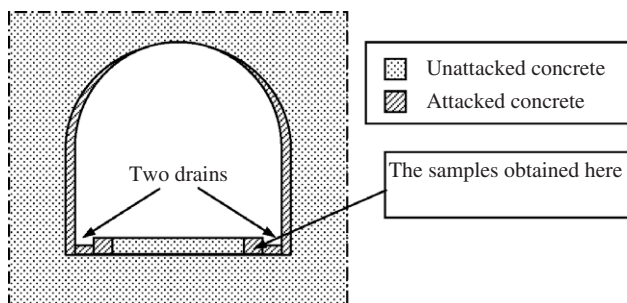
Fig. 2. Schematic illustration of the tunnel and areas most affected by TSA.

Fig. 2 shows a cross-section of the tunnel in the dam and highlights specific areas where damage has been observed. The damage is predominantly in the drainage channels but is also observed on the walls and roof in localities where the water enters the tunnel. The deepest effects appear to penetrate to around 100 mm from the surface. However, a full core analysis is recommended to determine the actual depth and type of attack observed at greater depths.

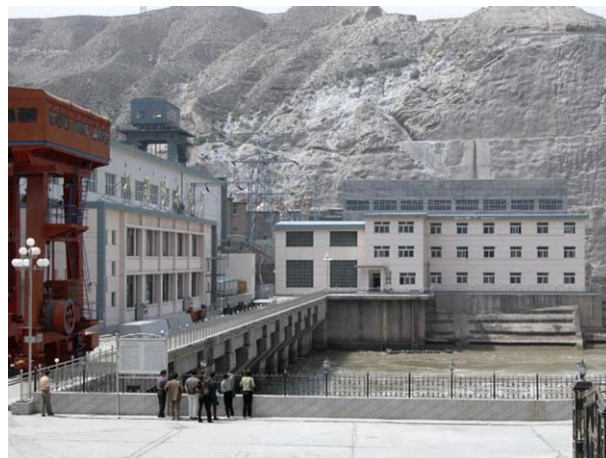
Fig. 3. Profile of Bapanxia Hydraulic Power Plant.

Fig. 3 shows a general view across the dam to the mountain, from where the aggressive salts originate. The lighter-coloured areas above the dam in Fig. 3 are, in fact, sulfate salt deposits on the surface of the soil. Consequently, the water penetrating the tunnel has enough sulfates (Table 1) to cause severe sulfate attack and is equivalent to a Class DS-5 sulfate solution [14]. Within the tunnel, temperatures range between 4 and 10 °C with a continuous relative humidity of more than 85%. Additionally, carbonated concrete in the tunnel, dissolved CO₂ in the water and dissolved carbonates in the water would appear to be a likely source of CO₃²⁻. Thus, conditions favourable to TSA are present.
