Deterioration of concrete in a hydroelectric concrete gravity dam and its characterisation

Ahmad Shayan ^{a,*}, Jack Grimstad ^b

Abstract

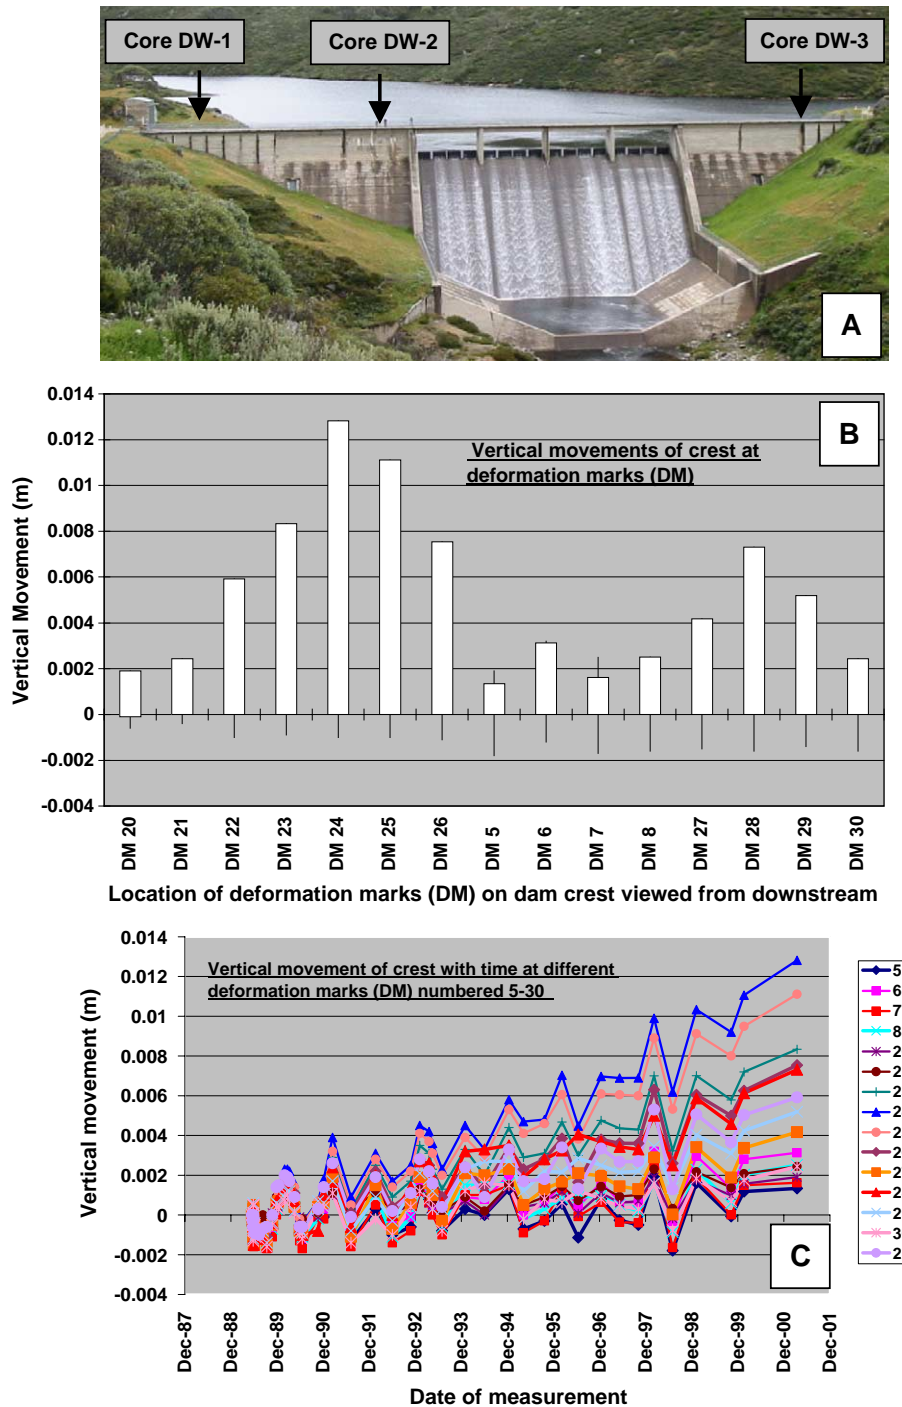
The dam and power station investigated are a part of the Snowy Mountain Hydro-Electric System and are under the control of Snowy Hydro Ltd. Routine measurements of movements in the dam wall had revealed that some sections of the dam had shown as much as 13 mm movement over the 13 years of measurement between 1988 and 2001, i.e. 1 mm/year. Fig. 1A shows a general view of the dam wall observed from downstream, and graphical presentation of the movements measured on various locations on the crest. Regularly spaced surveillance points had been located on the crest and deformation markers (DM), suitable for the measurement of vertical movement, installed on the crest. Fig. 1B shows the total vertical movement at each DM location on the crest, over the

measurement period, and Fig. 1C illustrates the change in the vertical movement over the same period for each measurement site. Note that the DM positions in Fig. 1B correspond to the same locations on the crest shown in Fig. 1A, i.e. locations of DM5–DM8 correspond to the spillway location. In order to maintain a high level of operational efficiency, in February 2002 Snowy Hydro Ltd. commissioned a review of this facility including the power generation components and the concrete structures. A preliminary inspection was first carried out on the power station and dam wall by the authors to ascertain their long-term durability. As a result, alkali-aggregate reaction (AAR) was suspected as the cause of deterioration of the concrete in the power station. Stronger evidence of AAR was observed on the dam wall, which were similar to previously reported cases of AAR in Australian dams [1–4].

Fig. 1. General view of the dam from downstream (A), vertical movement of crest at different positions on the crest (B), and trend of expansion at each location with time (C).
