Localized corrosion of steel sheet piling

Robert E. Melchers^{a,*}, Robert J. Jeffrey^a, Kayley M. Usher^b

^a Centre for Infrastructure Performance and Reliability, The University of Newcastle, Newcastle 2308, Australia

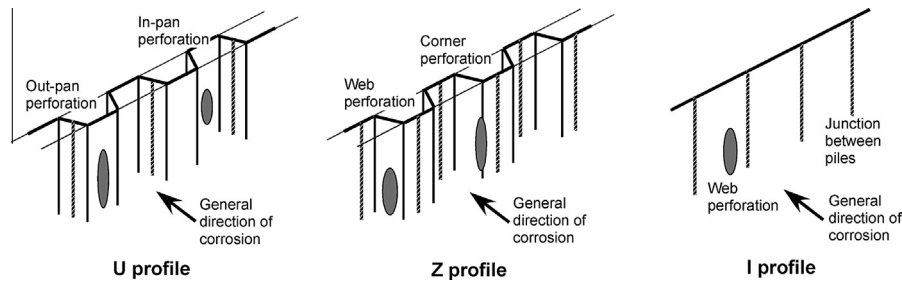
Besides the vertically oriented differential effect associated with ALWC, there is also a horizontal aspect, at least for the steel pile profiles used in practice. When ALWC occurs, it also has been observed that actual perforation of the sheet wall occurs in localized areas, apparently randomly between piles, with some individual piles showing perforation and others not. However, where perforation does occur, the general pattern of perforation is a remarkably consistent. For U-profile sheet piling the perforations occur predominantly on the out-pans (Fig. 1) while for Z-profile piles perforation appears to occur predominantly as elongated slots on the web-flange junctions corners or in the web of the Z shape (Fig. 1). The reasons for these observations currently are not understood [2].

Fig. 1. Schematic view of sheet pile walls formed by U, Z and I profile piles and the types and locations of perforations commonly observed. Also shown is the general direction of corrosion attack from the seaward side of the pile wall.

About 30% of commercially available U-profile pile sections have webs (pans) somewhat thinner than the remaining parts of the pile. This could be a reason for the earlier perforation of the webs. For U profile sheet piling the so-called out-pans (Fig. 1) typically are more exposed and this may be why they tend to perforate ahead of the in-pans. However, there are observations that sometimes the in-pans perforate first. It has been proposed [1] that this occurs when the out-pans are protected in some way, such as with timber piling but this clearly cannot be the general case. Similarly, while perforation at the corners or folds of the profile usually is associated with Z-profiles (Fig. 1) [6] similar perforation has been observed for some U-profile sheet piling (Fig. 2).

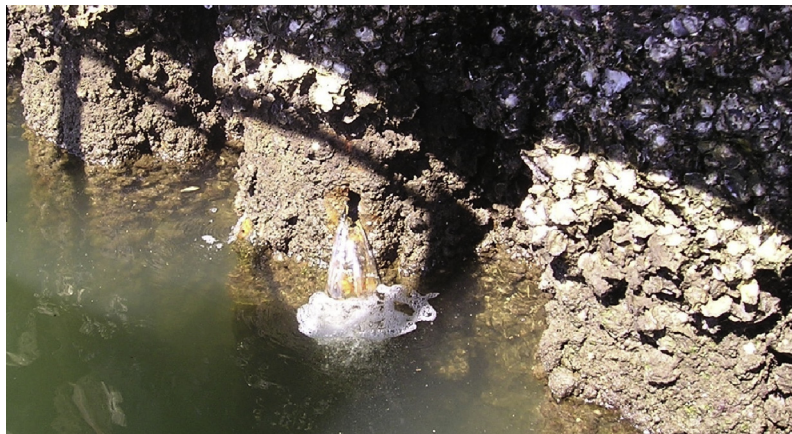
Fig. 2. Perforation and ground water draining into harbour waters at extreme low tide, showing perforation of a U profile pile near the junction between the web and the flange of the pile (Newcastle Harbour).
