Failure analysis of a 41-m long neutron beam line guide

George D. Quinn*, Oded Zilcha, J. Michael Rowe, Donald J. Pierce

National Institute of Standards and Technology, Gaithersburg, MD 29899, USA

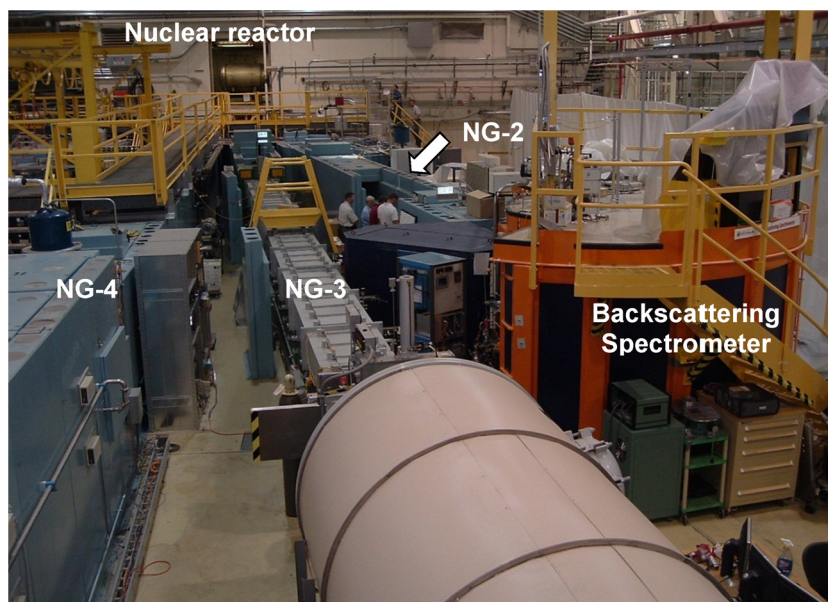
Fig. 1. The instrument hall with neutron beam lines. The source reactor is behind the wall at the far end of the hall. The fracture occurred in beam line NG-2 at the location marked by the large arrow where several of the authors are standing. This beam line is used with the backscattering spectrometer.

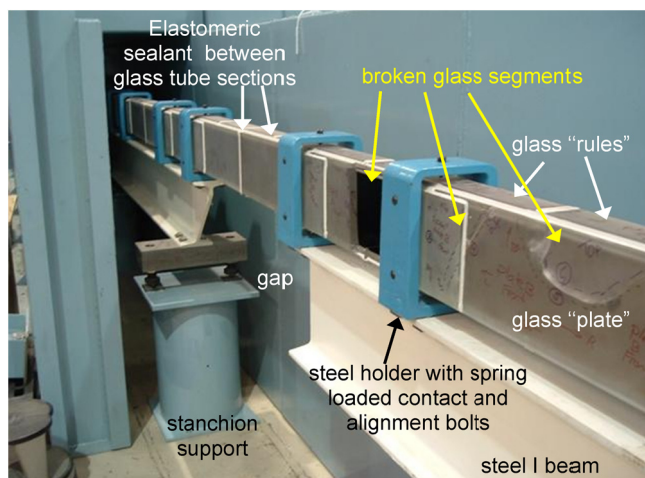
and none was detected. A vacuum check was also conducted and confirmed there were no leaks. Guide NG-2 was filled with helium after the vacuum check test and then again evacuated after three more weeks. During the second evacuation, a major failure of the guide occurred with fractures at several locations.

Fig. 2. The broken guide. One glass plate fell out and landed on the floor. Cracks occurred in several locations along the beam guide. None of the fractures started at the contact points. This view is looking toward the reactor. Large shields around the beam line were removed to gain access.
