# A micromechanical model of the cracking failure on structural steel components during hot-dip galvanizing

J. Carpio <sup>a,\*</sup>, J.A. Casado <sup>b</sup>, J.A. Álvarez <sup>b</sup>, F. Gutiérrez-Solana <sup>b</sup>

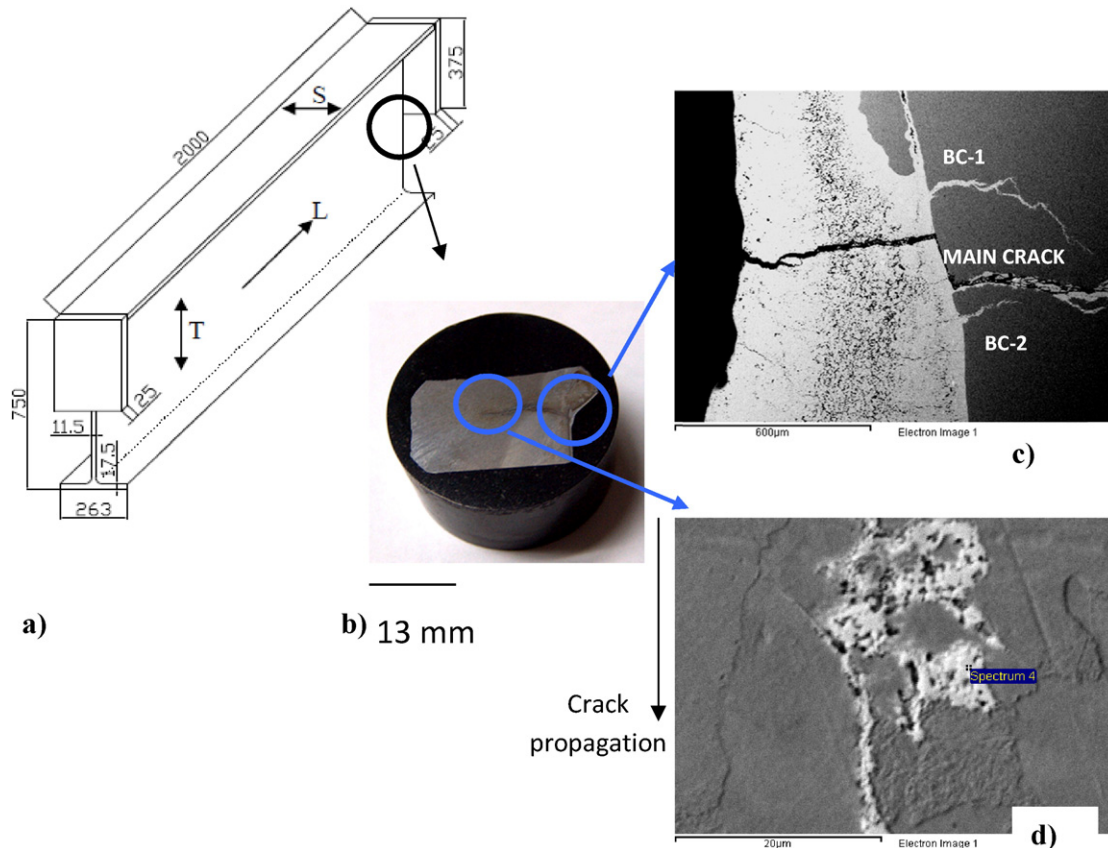
extremes, as shown in Fig. 1a). This beam, which had been submitted to galvanization in order to promote cracking, showed a failure in one of the two welding zones between the web and the semi-plate. After carefully cutting this zone of the profile, an extracted sample which was encapsulated (Fig. 1b)), polished and finally etched with nital 5% during 5 s, could be analyzed and examined in a Scanning Electron Microscope (SEM) with Energy-Dispersive X-ray Spectroscopy (EDS). SEM observations showed the existence of three cracks, as can be seen in Fig. 1c), the central one being much bigger than the others.

- High concentration of Sn at the crack path (galvanizing bath composition: 98% Zn, 1% Sn, 1% Pb and 0.1% Bi), which increases with the crack advance to the tip.
- In these zones of high Sn concentration, FeSn intermetallic compound was found (Table 1).
- Crack propagation along ferritic sub-grain boundaries was detected.

Fig. 1. Scheme of the extraction of the piece of steel with a failure during galvanizing: a) scheme of the original steel component; b) zone of the profile to be studied; c) general SEM micrograph of the origin of the 3 cracks; d) micrograph of a zone near to the crack of the case study of failure during galvanizing.
