Nuclear Instruments and Methods in Physics Research B

Improvement of the High Fluence Irradiation Facility at the University of Tokyo

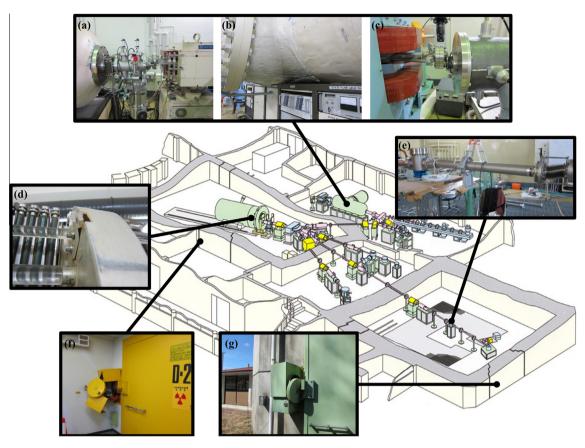
At 14:46 on March 11, 2011, the historic M9 earthquake struck Japan. During the main shock, the HIT facility, located 270 km from the epicenter of the main shock, was not severely damaged to both accelerators. In addition to the main shock, a M7.9 aftershock at 15:15 seemed to have caused severe damage as its epicenter was closer, at approximately 70 km, to the HIT. The major damages sustained due to the earthquake are summarized in Fig. 1.

During the earthquake, the Cockcroft-Walton accelerator collapsed from its supports, fracturing the accelerating tube. The connecting bellows between the accelerator and the other components were also fractured. As a result, practically all of the SF₆ contained inside the tank escaped into the atmosphere through the fractures in the accelerating tube and bellows. The inner shell covering the high voltage terminal of the Van de Graaff accelerator was shaken and released from the shell clamps that were severely deformed. A beamline pipe was broken at the ceramic insulator nipple, and some bellows connecting beamlines and chambers were also damaged. Two magnetic levitation-type turbomolecular pumps, both of which had been installed horizontally, became inoperable. It should be noted, however, that all other turbo molecular pumps including those installed vertically survived the megaquake, even though some were in operation at the time of the incident. Latching hardware on two swinging shielding doors was completely broken. Because one of the broken doors could not be closed manually and so was left partially open to the outside, a radioactive plume, which arrived from the damaged Fukushima Dai-ichi Nuclear Power Plant on March 15, contaminated the floor and wall inside the radiation-controlled area. Additionally, because the anchoring bolts could not bear the seismic shock, several components shifted slightly eastward. According to the GPS analysis of Geospatial Information Authority of Japan, the crust around Tokai-mura also shifted 1 m eastward [2], which is consistent with the shift direction of components.

Fig. 1. Summary of the seismic damage in HIT facility. (a) Low energy end, (b) tank, (c) high energy end of the 1 MeV tandem Cockcroft-Walton accelerator. (d) Bended shell clamp of the 3.75 MV single-ended Van de Graaff accelerator. (e) Fractured insulator and bellows of a beamline. (f, g) Broken latching hardware of swinging shielding doors. Fission product from Fukushima Daiichi NPP flew in through the partially open door at (g).
