# Foreign object damage on the leading edge of gas turbine blades

Seyed Masoud Marandi, Kh. Rahmani, Mehdi Tajdari

## ABSTRACT

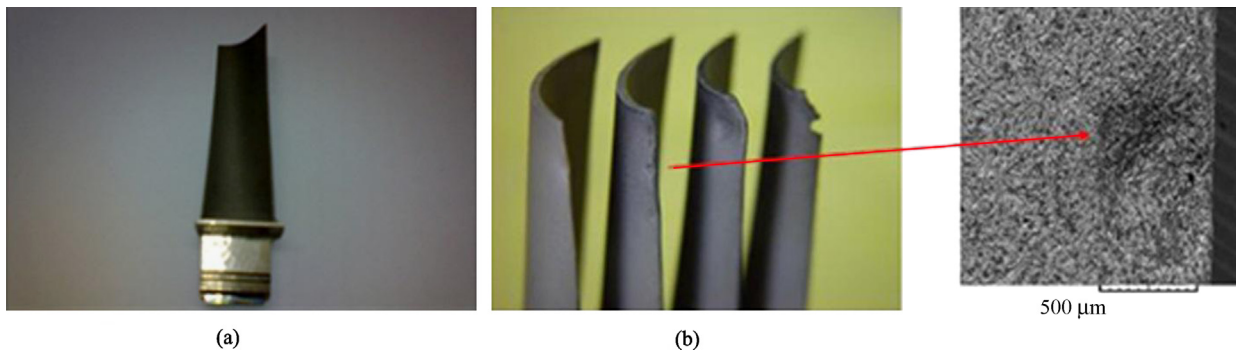
are high which cause the blade coating becomes useless. So far, there has not been any history of works about FOD on the leading edge of real case uncoated gas turbine blades. In this paper, the investigation about foreign object damage on the leading edge of uncoated gas turbine blades was performed by FEM, and then validated by photoelastic and quasi-static methods. There are several superalloy blades that have microcracks at three regions, which are scrutinized by Kh. Rahmani et al. Due to finding these microcracks initiation reasons at mentioned sites, FEM is applied in this paper. It is obtained that these reasons are residual stresses and elastic stress concentration factor. FOD on the several uncoated gas turbine blades of the jet engine is shown in Fig. 1(b), while the undamaged gas turbine blade is shown in Fig. 1(a).

Fig. 1. (a) The undamaged blade. (b) FOD on the several uncoated gas turbine blades of the jet engine [19].
