# Progressive collapse of a drilled-shaft bridge foundation under vessel impact

### Y.E. Lu<sup>a</sup>, L.M. Zhang<sup>b,\*</sup>

#### ABSTRACT

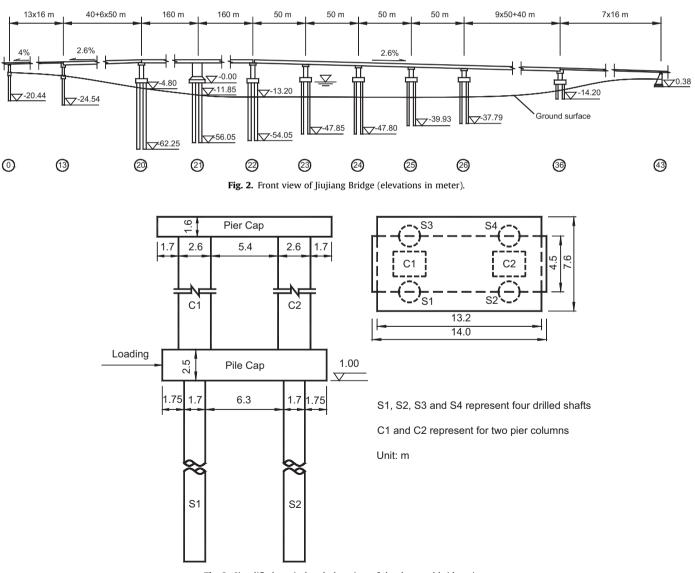
Fig. 3. Simplified vertical and plan view of the damaged bridge piers.

Piers no. 23, 24 and 25 had the same type of structure. Each consisted of four drilled shafts, two columns, one pile cap, and one pier cap, as shown in Fig. 3. In the figure, S1, S2, S3, S4, C1 and C2
