The detection, inspection, and failure analysis of a composite wing skin defect on a tactical aircraft

A routine ultrasonic inspection of a lower wing skin revealed a defect between the titanium alloy stepped-lap joint and composite surface. Since the wing skin passed high-tension loads through to the fuselage, the possible presence of such a defect had the potential to compromise other aircraft with the same construction. Naval Air Station (NAS) Jacksonville personnel took the lead in coordinating the approach to identify, diagnose, and manage the defect by synchronizing efforts between non-destructive testing, metallurgy, and composites experts. The defect was identified as a disbond between the splice plate and bond primer that led to a delamination fatigue crack between composite plies. From these results, staff implemented a novel inspection program to search for similar defects in the fleet.

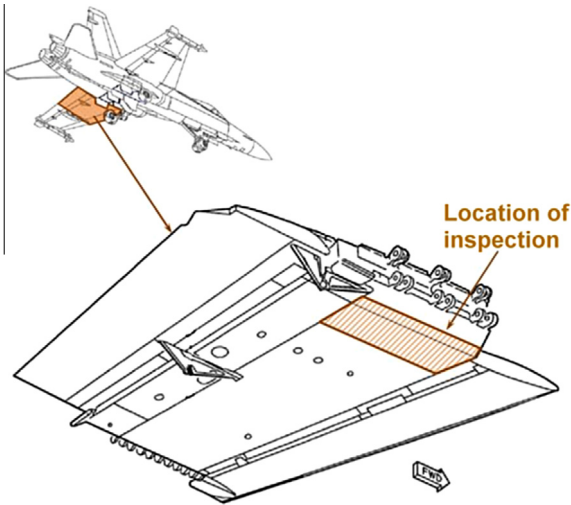
Such was the case when a defect was located in a composite-titanium bonded joint on a tactical aircraft wing during a routine ultrasonic inspection of the wing skins (location shown Fig. 1). This joint was comprised of woven carbon-fiber reinforced-epoxy composite bonded to a titanium-alloy stepped-lap joint, which conferred high mechanical properties with low life-cycle costs [14]. The titanium splice plate was coated with an epoxy bond primer, and was bonded to the composite with an epoxy film adhesive. This layup was designed to impart high toughness, shear strength,

Fig. 1. The location of defect found on the lower wing-root stepped-lap joint.

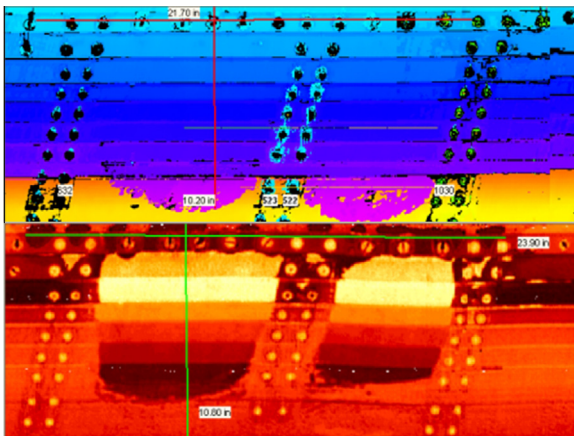
The initial NDT (ultrasonic resonance and pulse-echo C-scan) images are illustrated in Fig. 2. This inspection used a resonance C-scan at relatively low frequency and a pulse-echo C-scan at higher frequencies. These scanning modes yielded information regarding the condition of composites and the integrity of the composite-to-titanium bonded joint. On this particular aircraft, operators found a large defect indication with two lobes. These lobes were largest between wing spars and smallest along the sections fastened to the spars.

Fig. 2. Resonance C-scan (left side) and pulse-echo depth and amplitude C-scans (right) of the lower wing skin defect.

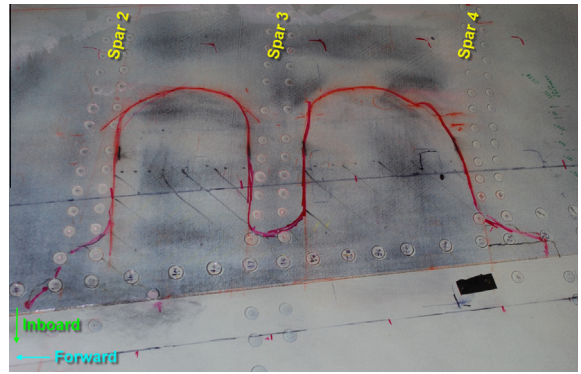
Meticulous A-scan ultrasonic inspections were used to outline the boundary, as well as the likely location of the defect through the thickness of the lower wing skin from the outer mold line (OML), as shown in Fig. 3. Fig. 4 illustrates the nature of the loca-

Fig. 3. Outline of the detected defect (red line) found by ultrasonic scanning on the lower wing skin. (For interpretation of the references to color in this figure legend, the reader is referred to the web version of this article.)

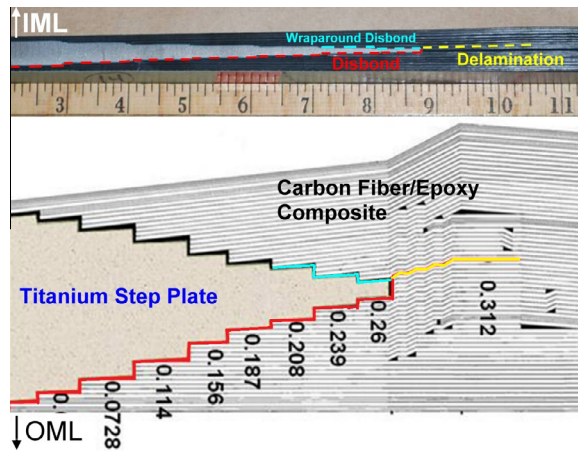
Fig. 4. Image (above) and schematic (below) of a cross-section of the lower wing skin, illustrating the location of the disbond (red) and subsequent delamination (yellow) and wraparound disbond (blue). (For interpretation of the references to color in this figure legend, the reader is referred to the web version of this article.)

tion of the defect in cross-section, which was found to be a joint disbond with subsequent delamination and wraparound disbonding. The defect had propagated outboard from the inboard stepped-lap joint. However, there was a discernible elevation of the composite over the defect at the inboard joint seam. In addition, there was evidence of fuel leakage from one of the fastener holes near the kick rib (illustrated in Fig. 5).

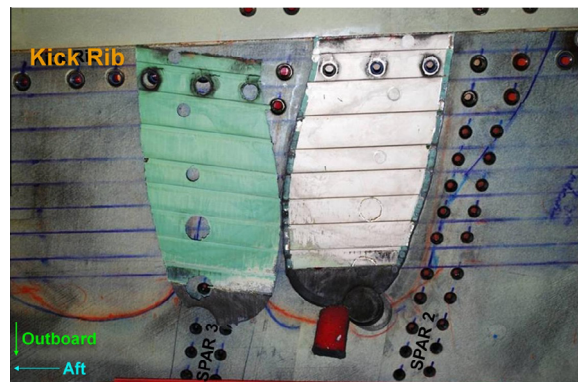
Fig. 5. The large section of composite side of the defect after excising between two spars.
