# An experimental investigation into localised low-velocity impact loading on glass fibre-reinforced polyamide automotive product

Zakaria Mouti<sup>a</sup>, Keith Westwood<sup>b</sup>, Darren Long<sup>b</sup>, James Njuguna<sup>a,\*</sup>

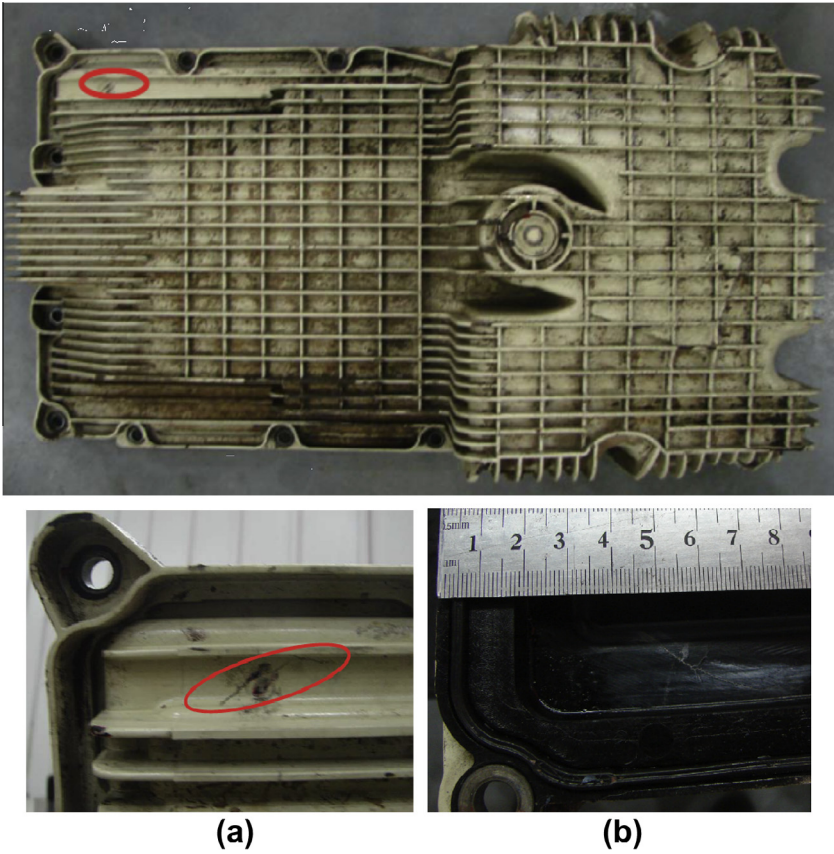
The under carriage of any road going production vehicle contains many vulnerability components. Driving on gravel surfaces, tough roads, near construction sites or during road maintenance can cause stones to be ejected from the wheels which then are projected into the air and could possibly damage the under carriage area of a vehicle or the vehicle can hit a boulder with potential serious consequences on low-fitted components. The main concern of this research is the impact performance and damage caused by those stones to a recently converted engine oil pan for light utility vehicles into PA66 reinforced with 35% of short glass fibre. Fig. 1 shows an early version of the thermoplastic oil pan that has been damaged by foreign flying debris, identified as a stone by the fragments left on the impacted surface (Fig. 1a). The engine oil was seeping out through the crack from the inner side (Fig. 1b) to the outer side of the pan (Fig. 1a).

Fig. 1. Thermoplastic oil pan crack failure, (a) outer side, and (b) inner side [2].

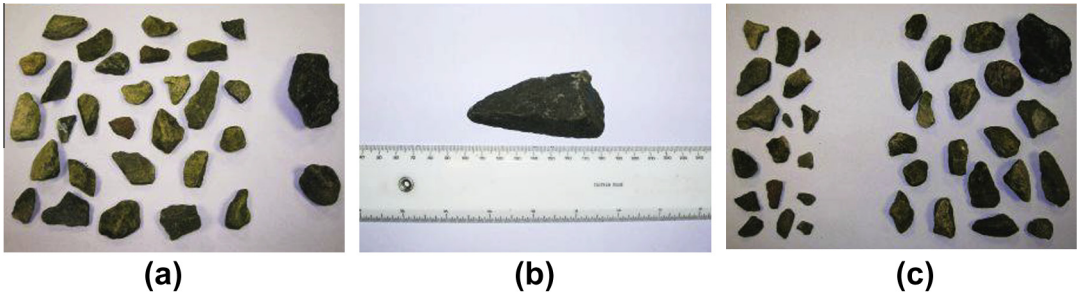
The characteristics of stones likely to cause damage into the engine oil pan presented in the Fig. 1 were quantified allowing the measurement of road stones typical mass and size [9]. The granite stones shown in Fig. 2a weigh less than 17 g and all fit into the damaged area between two consecutive ribs except the two big

stones on the right side; the rounded stone weighs 21 g and the larger one weighs 78 g. There are variable gaps between the ribs in the area of impact. A 87 g random stone with a pointy profile

is able to fit into the gap where damage is evident, Fig. 2b. A possible solution would be to reduce the rib spacing so as to exclude more stones, Fig. 2c. However, the mistake would be to overload the oil pan structure with protective features. The compromise is in the balance in where more or improved ribs are disposed in the areas prone to impacts.

Fig. 2. Collection of random stones.
